**DOWNTOWN PLAZA & BANDSTAND
500 Main Plaza
New Braunfels, TX 78130**

ADA SELF-EVALUATION FACILITY SURVEY

New Braunfels Downtown Plaza & Bandstand

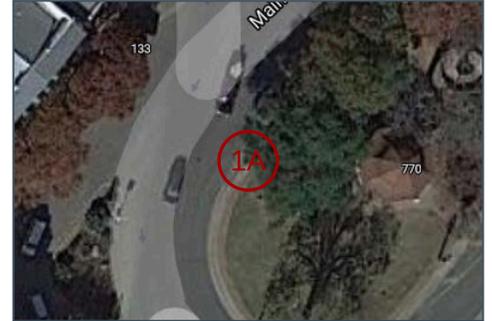
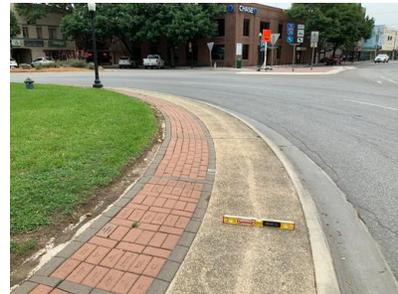
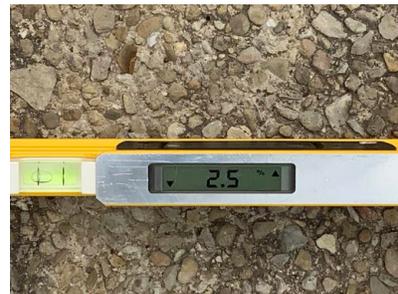
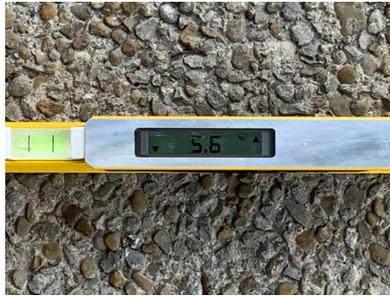
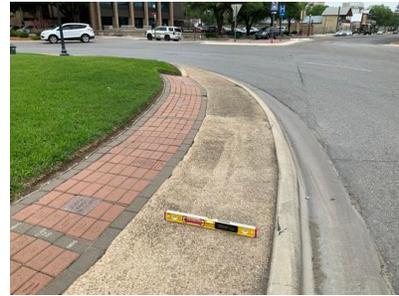
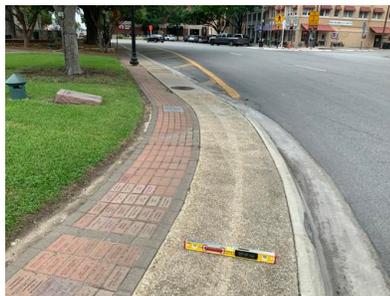
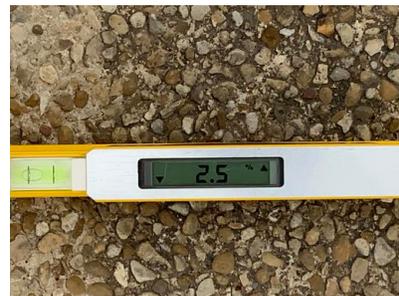
Sheet
C1

Description
Entire perimeter sidewalk has cross slopes up to 5.6% and excessive changes in level.

Recommendation: Remove and replace sidewalk.
584' x 3' (1752 SF)

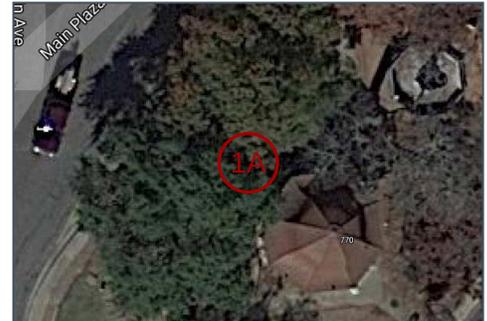
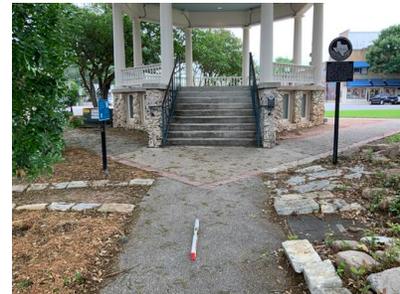
Sheet
C2

Description
The route from the perimeter sidewalk to the bandstand stairs has running slope of up to 6.9%.

Recommendation: Replace sidewalk. (75 SF)

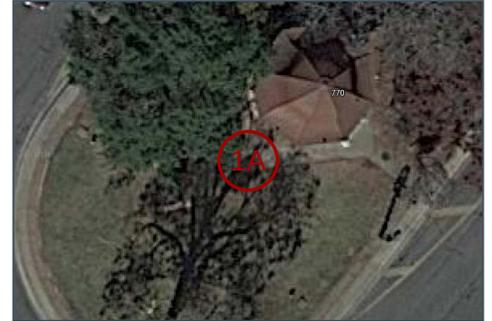
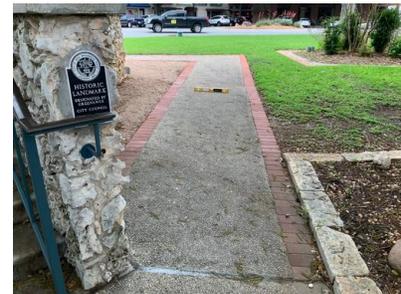
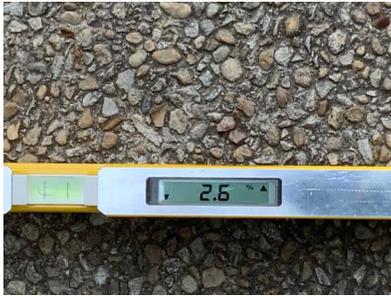
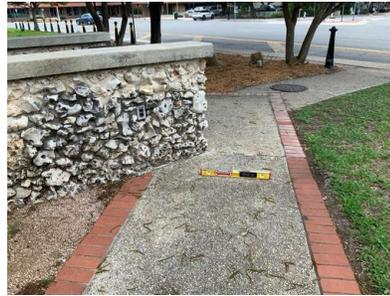
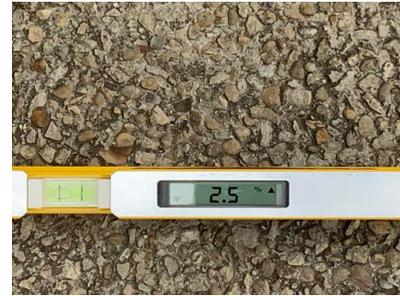
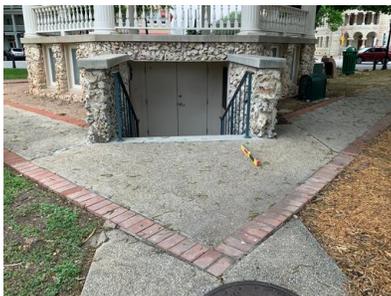
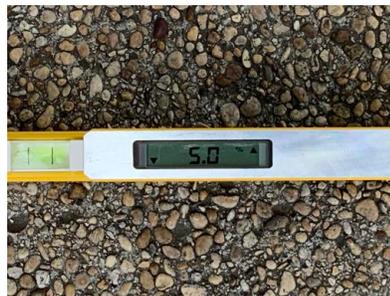
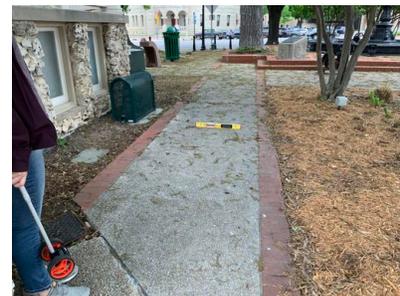
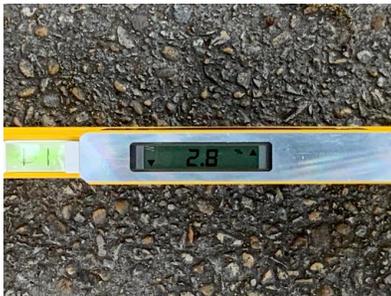
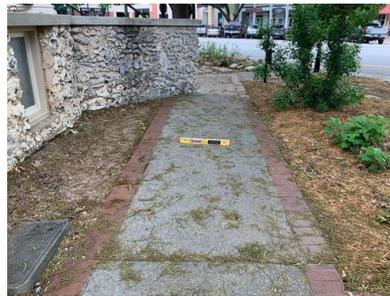
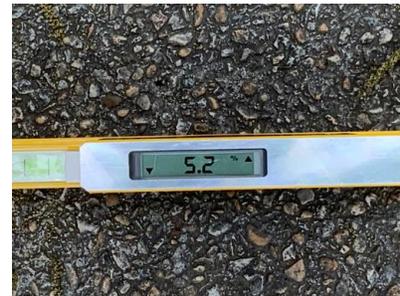
C2

The sidewalk around the bandstand has cross slopes ranging from 2.5% to 5.8% and openings greater than 1/2".

Recommendation: Remove and replace sidewalk. (480 SF)

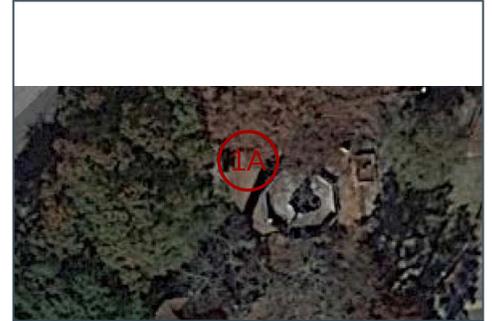
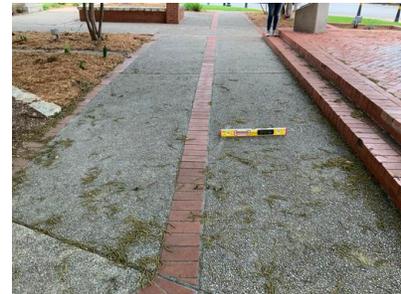
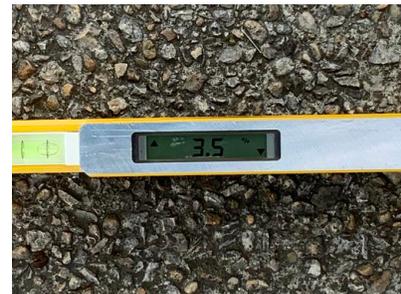
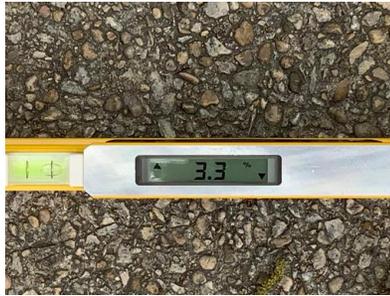
Sheet
C2

Description
The sidewalk to and around the fountain has a cross slope ranging from 2.7% to 8%.

Recommendation: Remove and replace sidewalk. (600 SF)

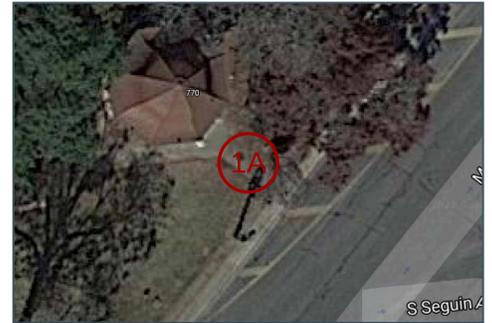
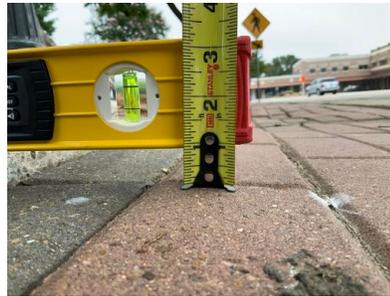
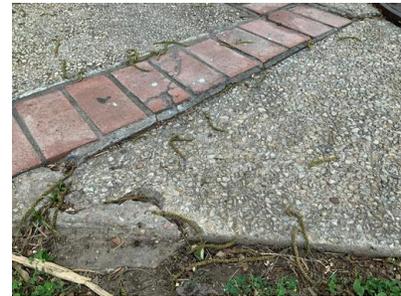
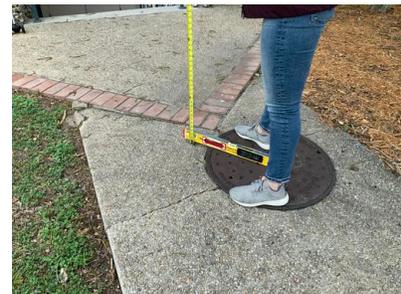
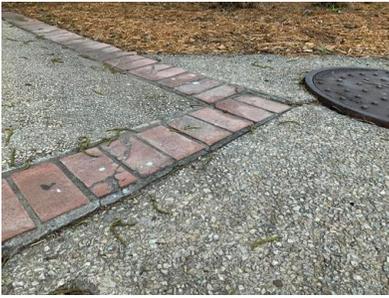
C2

The route from the perimeter sidewalk to the back of the bandstand has multiple changes in level greater than 1/2".

Recommendation: Replace sidewalk. (75 SF)

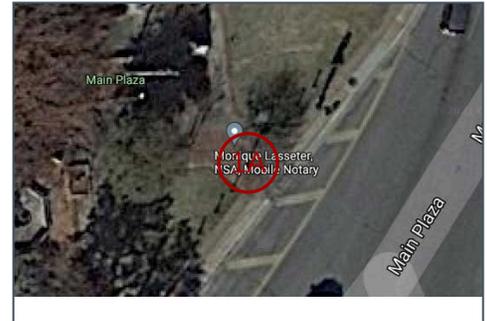
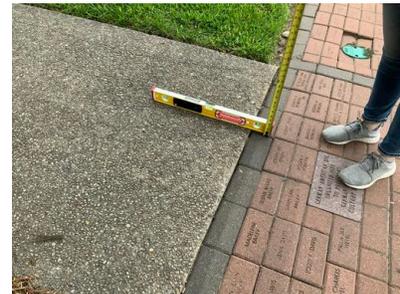
Sheet
C3

Description
The south sidewalk has an abrupt change in level of 1/2" at the perimeter sidewalk.

Recommendation: Grind edge to a 1:2 slope.

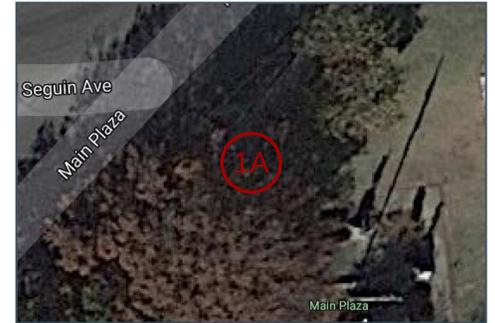
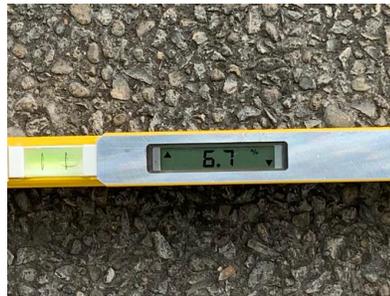
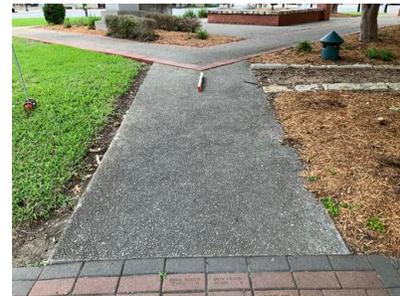
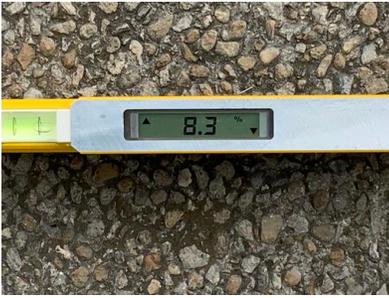
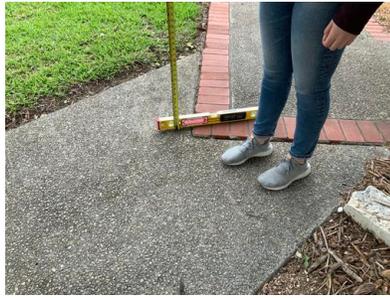
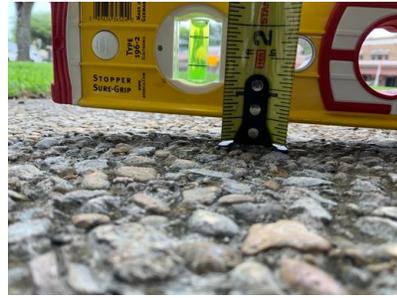
C3

The sidewalk from the north perimeter sidewalk has a running slope of up to 8.3% and changes in level in excess of 1/2".

Recommendation: Remove and replace sidewalk. (75 SF)

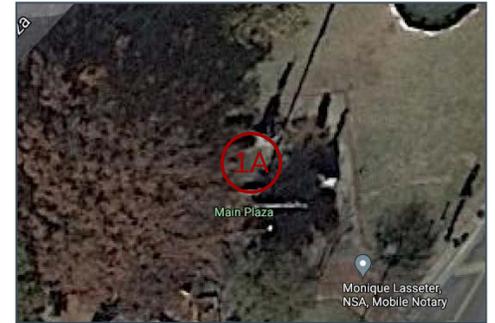
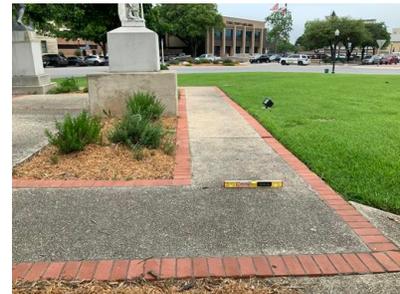
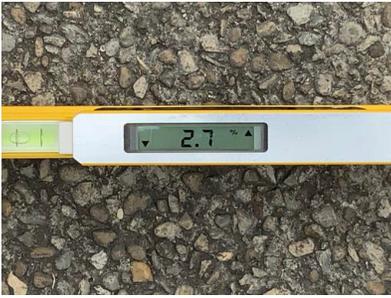
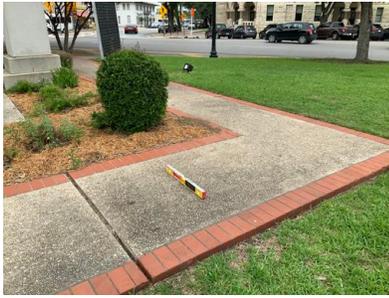
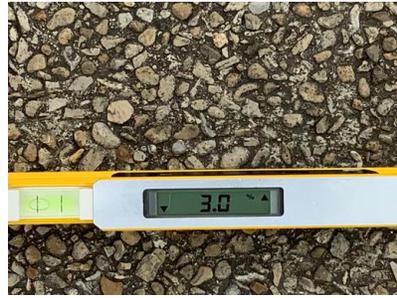
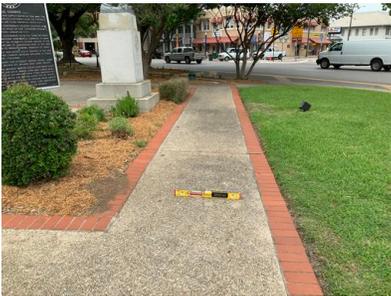
C3

The sidewalk around the memorial has cross slopes ranging from 2.5% to 3.5% and excessive gaps and changes in level.

Recommendation: Remove and replace sidewalk. (660 SF)

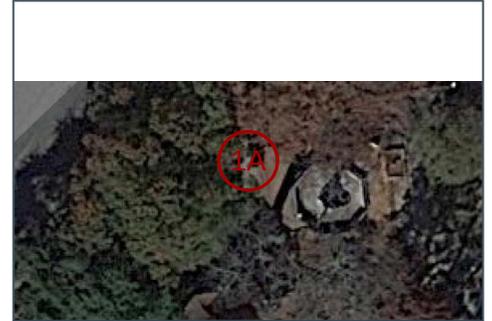
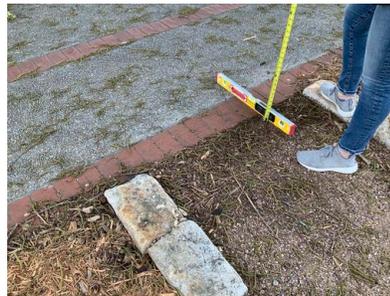
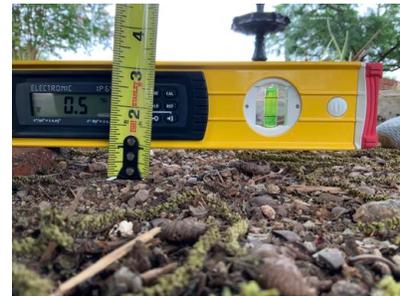
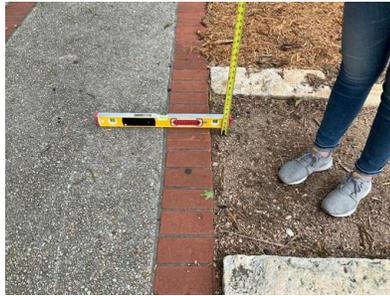
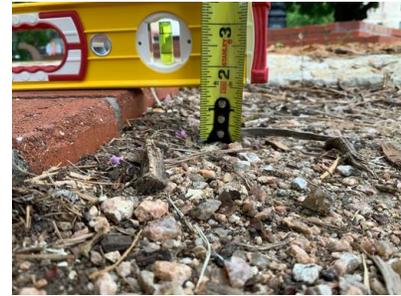
C2

The two connecting decomposed granite paths are not stable or firm and have excessive changes in level.

Recommendation: Replace route with paved sidewalk.
(40 SF)

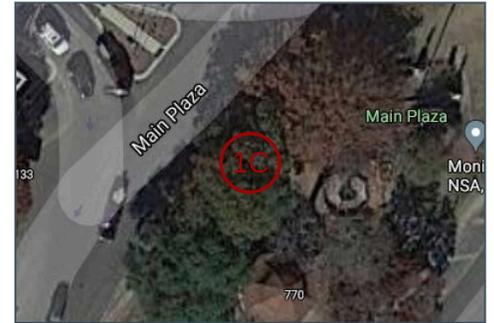
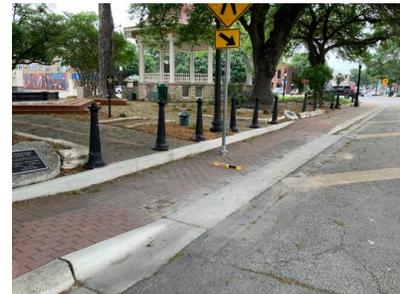
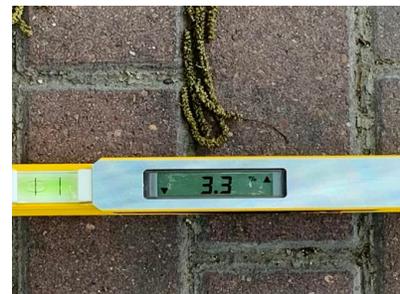
Sheet
C1

Description
Both ramps and landing have excessive cross slopes ranging from 3.3% to 3.7%.

Recommendation: Remove and replace curb ramp.

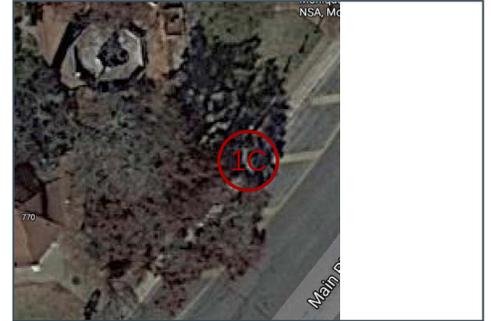
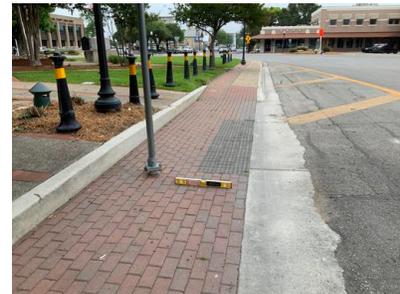
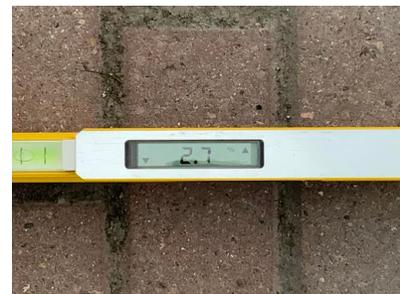
Sheet
C2

Description
The right-hand ramp and landing have a cross slope ranging from 2.6% to 3.4%.

Recommendation: Remove and replace curb ramp.

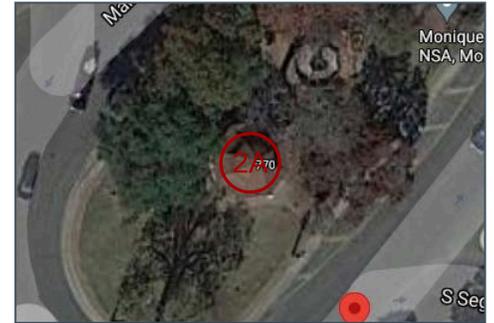
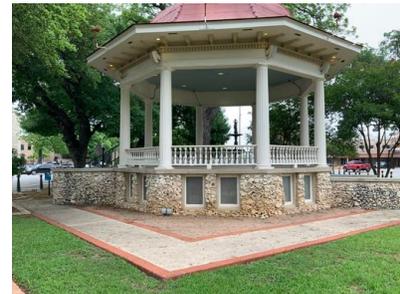
C1

No accessible route is provided to the bandstand.

Recommendation: Install a platform lift.

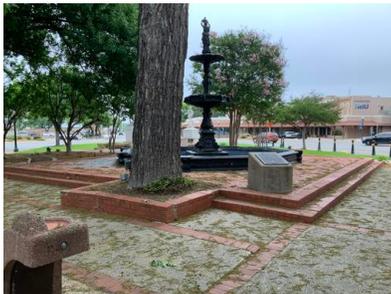
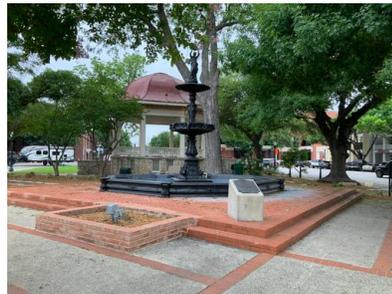
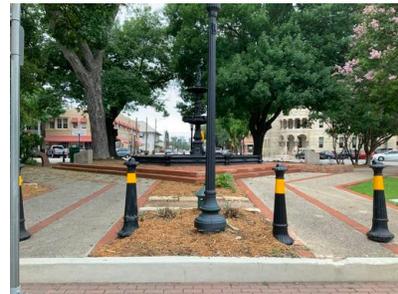
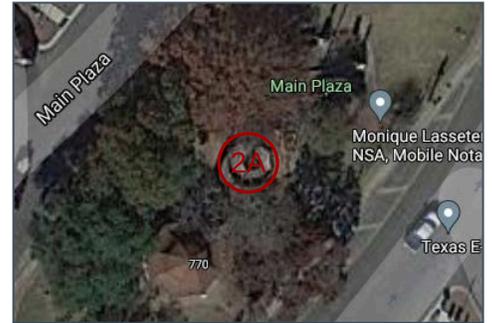
Sheet
C1

Description
No accessible route is provided to fountain or memorial plaques.

Recommendation: Install a ramp.

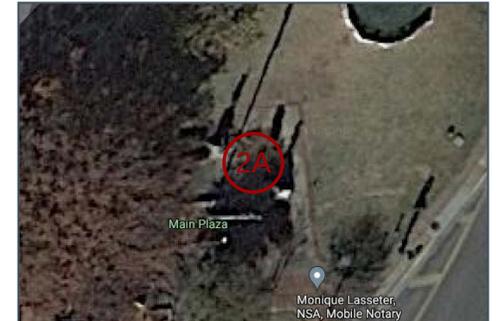
C3

The north corner of the sidewalk has a cross slope of approximately 2.4%

Recommendation: Remove and replace sidewalk. (100 SF)

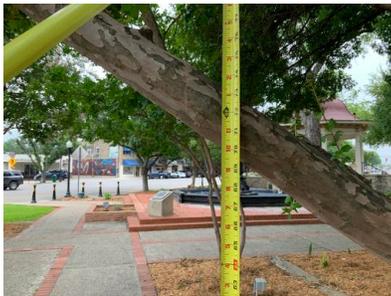
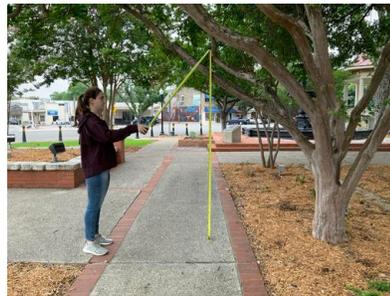
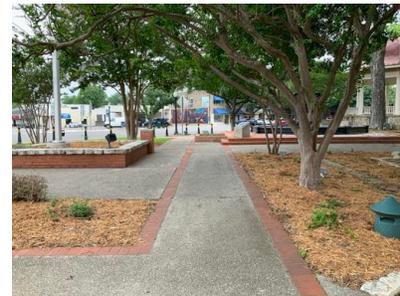
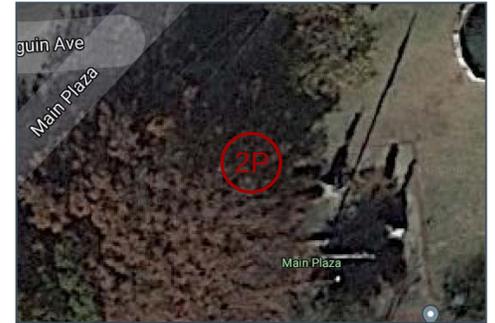
C3

The north side of the sidewalk around the memorial has low tree branches with an overhead clearance of only 70".

Recommendation: Trim tree branches.

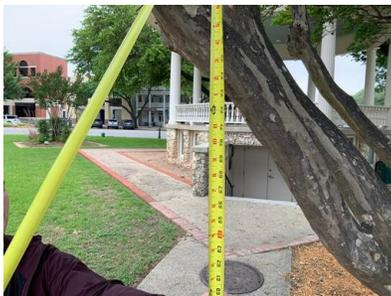
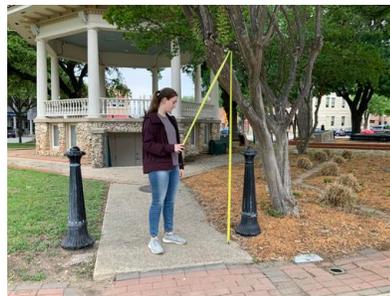
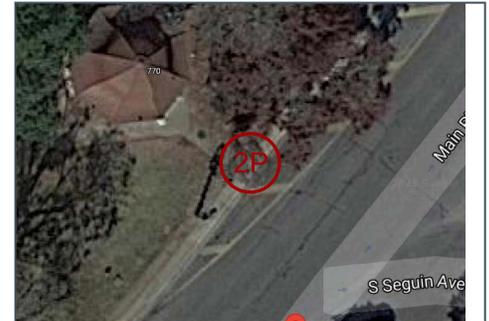
Sheet
C2

Description
The route from the perimeter sidewalk to the back of the bandstand has low tree branches with an overhead clearance of only 74".

Recommendation: Trim tree branches.

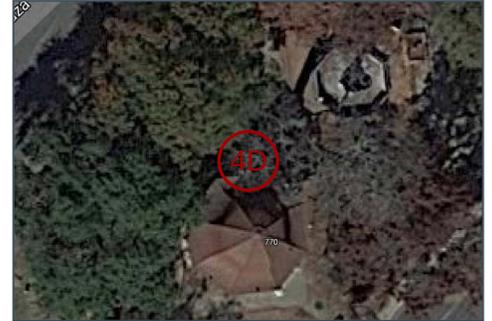
C2

The single drinking fountain is accessible, but no standing height fountain is provided.

Recommendation: Install a second fountain with the spout 38" to 43" high.
