**PRINCE SOLMS PARK  
100 Liebscher Drive  
New Braunfels, TX 78130**

This report has been developed as part of an overall self-evaluation and transition planning effort undertaken by the City of New Braunfels and as required by the Americans with Disabilities Act Title II Regulations for state and local government entities. The conditions cited within this report represent the findings of our team at the time of evaluation on September 17, 2019. Our survey included public areas and other areas where city programs are offered.

# Prince Solms Park

Oct 14, 2019

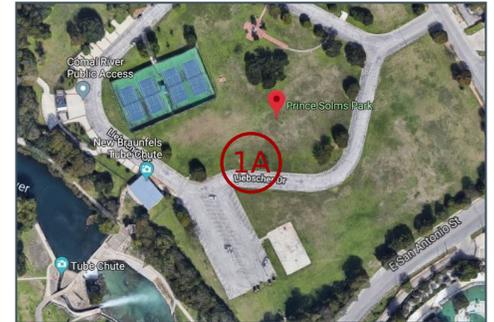
No direct accessible routes are provided between disc golf course holes 2 and 3, 5 and 6, and 8 and 9 of the disc golf course.

Recommendation: Add two curb ramps on each side of Liebscher Drive between holes 2 and 3. Add one curb ramp across Liebscher Drive from the curb ramp access near the tennis court for access between holes 5 and 6. Add one curb ramp across Liebscher Drive from the curb ramp near the Tube Chute Building near the south side of the tennis courts for accessible between holes 8 and 9.

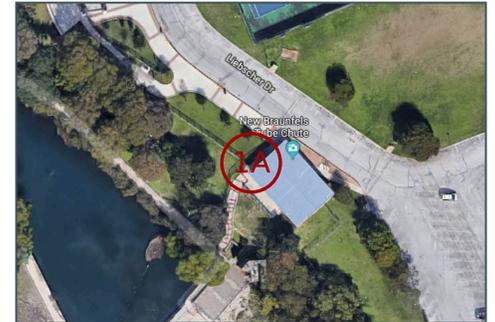
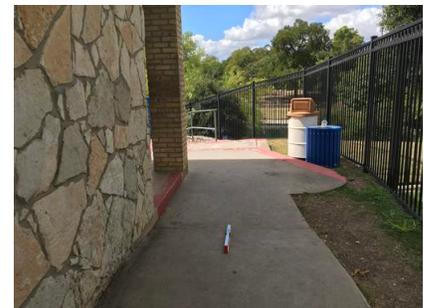
3

The sidewalk leading from the loading zone to the admission window has a running slope of approximately 11.5% as it nears the admission window and an approximate 1/2-inch vertical change in level due to heaving.

Recommendation: Remove and replace approximately 15 feet of sidewalk (75 s.f.) and create a route flush with the admission window step. See Item #71 for additional route requirements at this building.

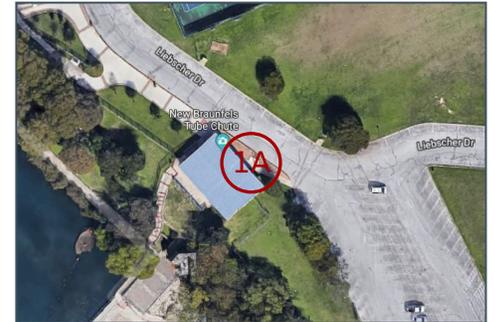
3

The sidewalk leading from the accessible parking space has a change in level of greater than 1/2-inch due to heaving.

Recommendation: Grind edge to ease transition.

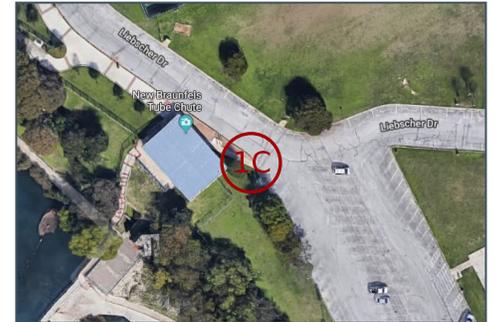
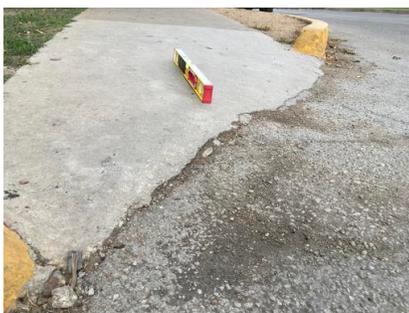
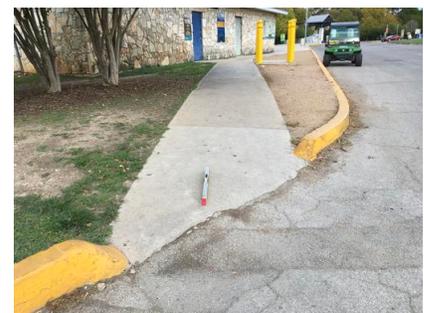
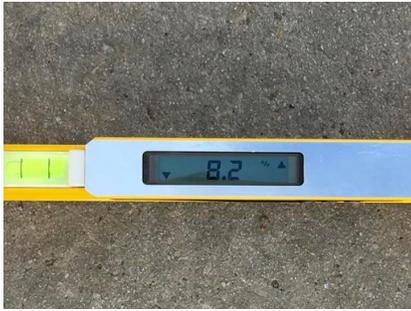
3

The curb ramp leading from the accessible parking space has a cross slope up to 8.2% and a running slope up to 10%. No flush transition is provided at the bottom, and the top landing and sidewalk has a cross slope of approximately 3%.

Recommendation: Remove and replace the curb ramp and approximately 15 feet (75 s.f.) of sidewalk at the top of the ramp.

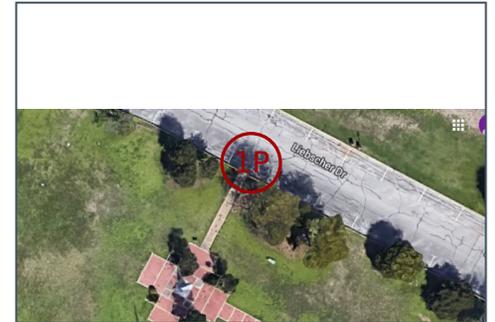
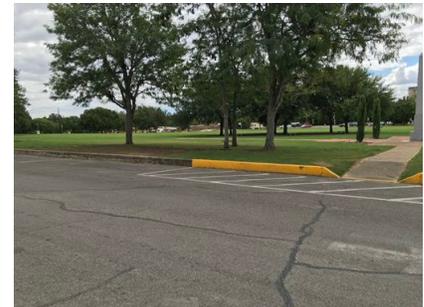
5

No accessible parking is provided near the veterans memorial.

Recommendation: Add one accessible parking space on the shortest accessible route to the memorial. Remove grass area and expand paving to create a minimum 5-foot wide access aisle adjacent to the parking space. Install a vertical sign.

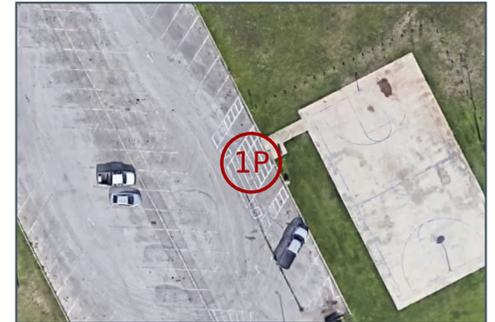
4

- 1) Both parking spaces and the access aisle have an approximate 3.4% to 4.4% cross slope in the north/south direction.
- 2) The northernmost parking space meets the requirements for a van space, but no van sign is provided.

Recommendation: Regrade and restripe accessible parking to have a maximum 2% slope in all directions. Add a van designation sign to the northernmost space.

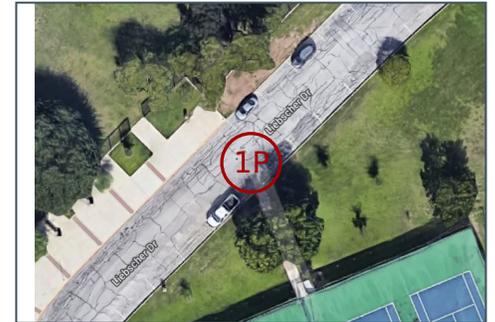
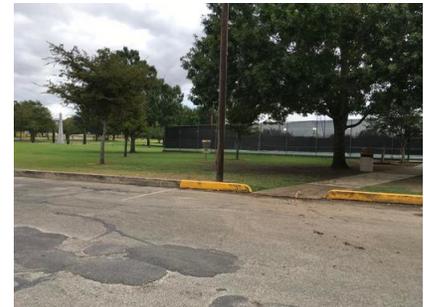
5

No accessible parking is provided near the entry to the tennis courts.

Recommendation: Add one accessible parking space on the shortest accessible route to the tennis courts. Remove grass area and expand paving to create a minimum 5-foot wide access aisle adjacent to the parking space. Install a vertical sign.

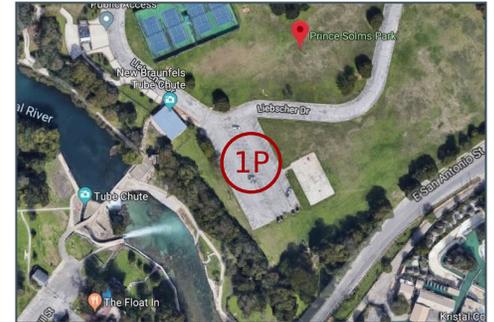
2

A total of 175 parking spaces are provided in the lot and along Liebscher Drive. Three accessible parking spaces are provided - one at the tube chute building and two at the basketball court. A minimum of 6 accessible parking spaces are required, and of those, at least one must be van accessible.

Recommendation: Add an additional 3 accessible parking spaces, including one more space at the Tube Chute Building, one at the tennis courts (see Item #91) and one at the veterans memorial (see Item #54).

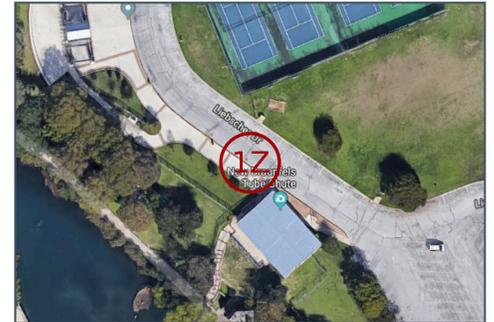
3

No marked aisle is provided at the accessible loading area near the curb ramp at the Tube Chute Building.

Recommendation: Stripe a minimum 5-foot wide and 20-foot long aisle near the curb ramp.

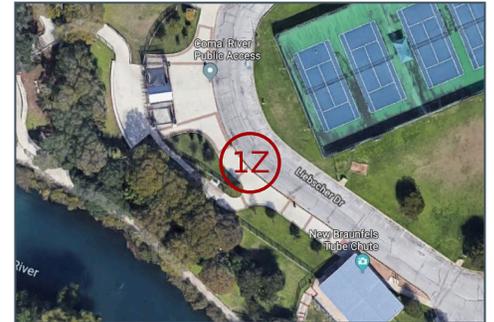
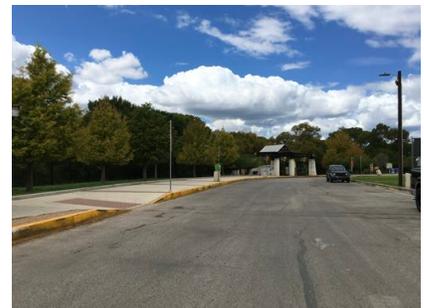
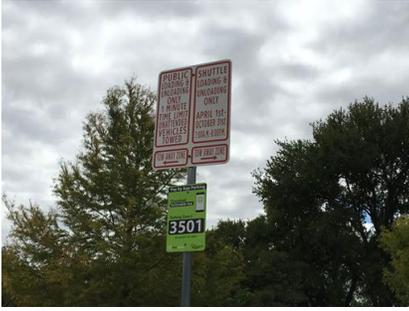
3

Approximately 140 feet of public passenger loading length is provided. At least one accessible loading zone must be provided for each 100 feet of loading zone length or fraction thereof. One curb cut is provided near the Tube Chute Building, but a second accessible loading area is required.

Recommendation: Add a curb ramp near the Gateway and stripe a minimum 5-foot wide and 20-foot long access aisle near the ramp.

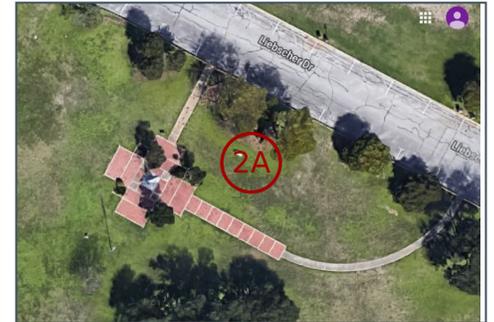
5

None of the benches are located on an accessible route.

Recommendation: Relocate one bench along the paving area at the memorial.

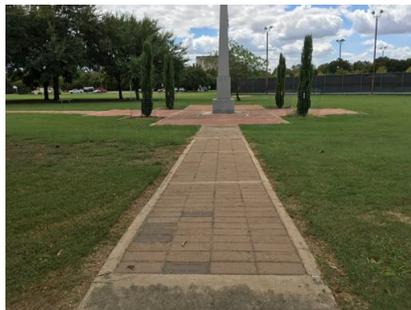
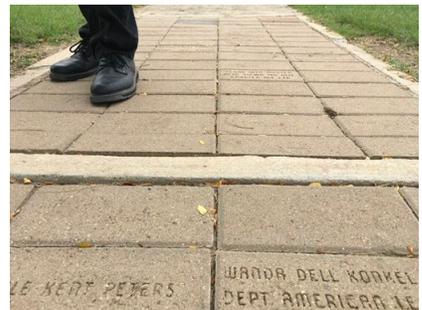
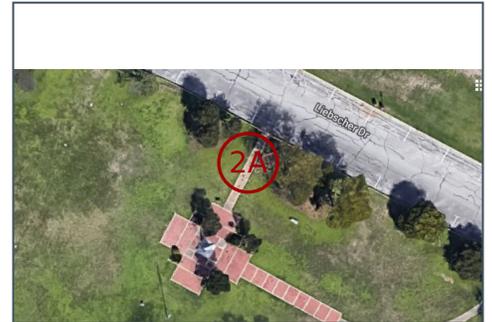
5

The memorial pavers along the route to the veterans memorial are irregular and create changes in level in excess of 1/4-inch in multiple locations.

Recommendation: Remove and reinstall pavers (approximately 180 s.f.).

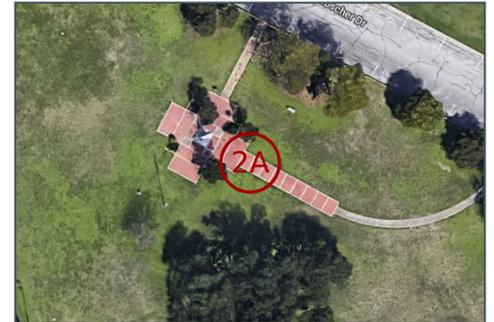
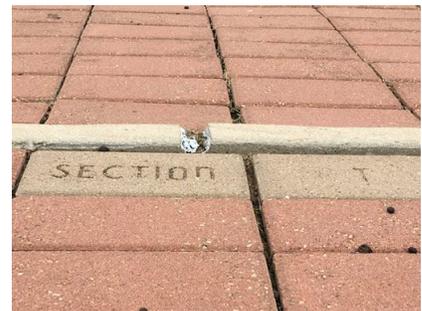
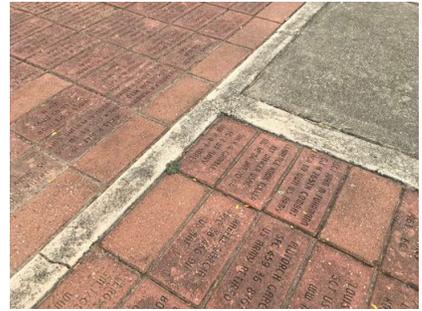
5

There are changes in level of up to 1-inch in some locations between the concrete bands and memorial brick pavers and between some of the brick pavers.

Recommendation: Remove and reinstall brick pavers (approximately 1400 s.f.), replacing base as necessary.

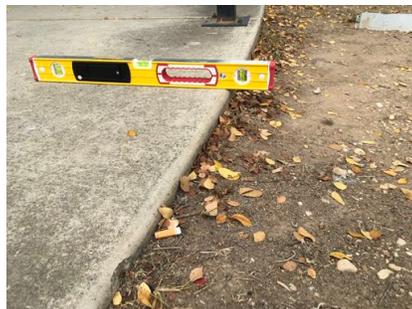
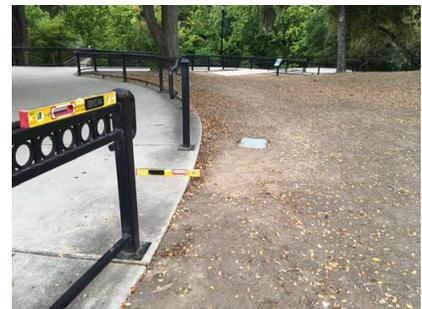
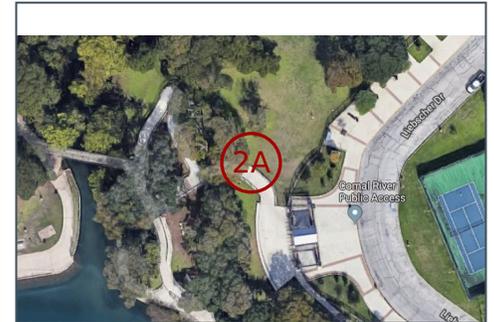
The route to the disc golf course from the sidewalk has a change in level of approximately 3 inches between the sidewalk and the grass surface.

Recommendation: Install a ramp with a slope of no more than 1:12 that dives beneath the grass and dirt surface to accommodate erosion.

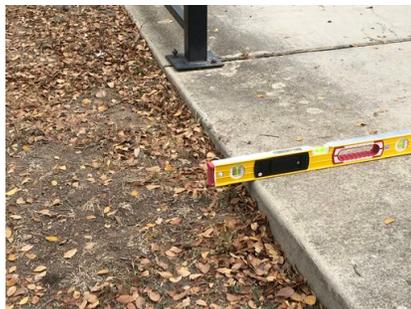
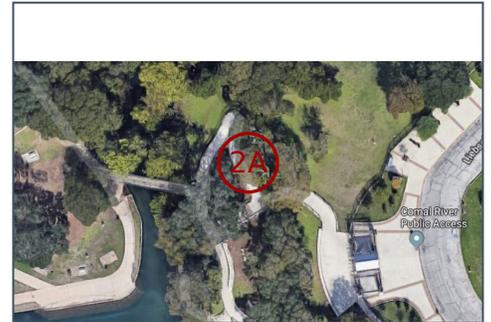
The route to the disc golf course from the sidewalk has a change in level of approximately 3 inches between the sidewalk and the grass surface.

Recommendation: Install a ramp with a slope of no more than 1:12 that dives beneath the grass and dirt surface to accommodate erosion.

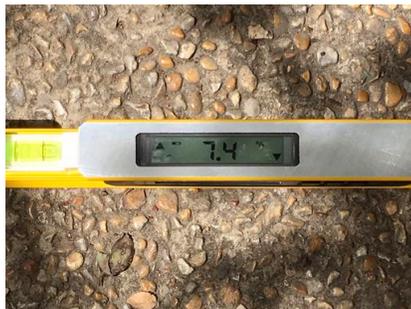
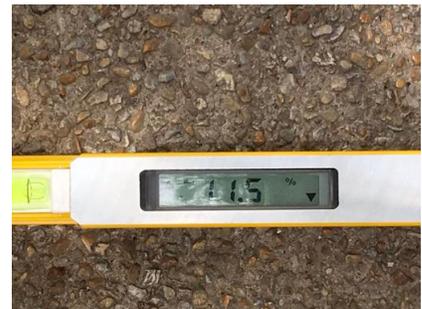
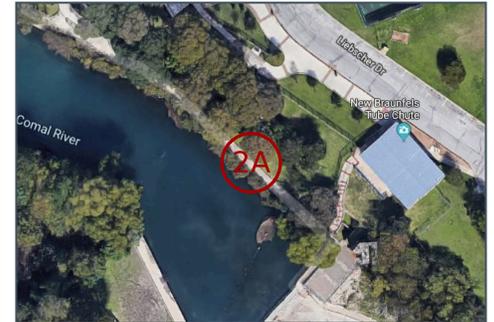
3

The sidewalk between the ramp from the Gateway and the tube chute observation area has a cross slope of up to 11.5% for approximately 230 feet.

Recommendation: Remove and replace sidewalk (approximately 1150 s.f.).

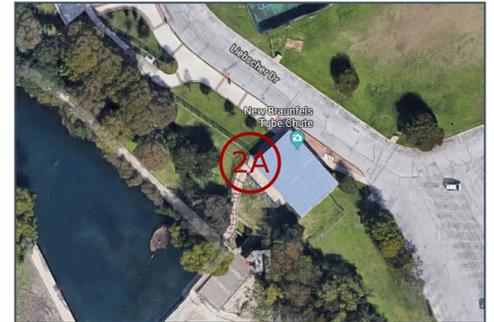
3

A 5-inch high step is provided at the admission counter.

Recommendation: See Item #47 for recommended correction.

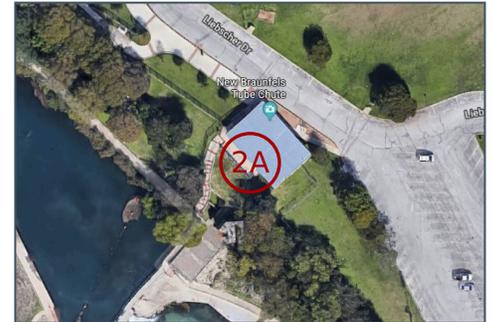
3

There is a 6-inch step into the building for access to First Aid and restrooms.

Recommendation: Build up sidewalk to match the elevation of the curb between the admissions counter and the building entrance for approximately 25 feet (125 s.f.). See Item #47 for related comments.

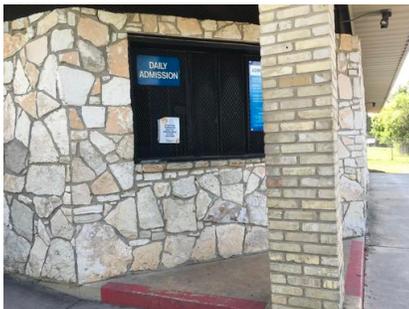
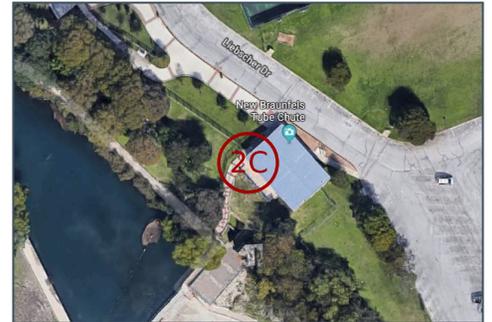
3

The admission counter measures 42 inches high to the top.

Recommendation: Create an accessible counter that is at least 36 inches wide and no more than 36 inches high with a 30"x48" clear floor space for a parallel approach.

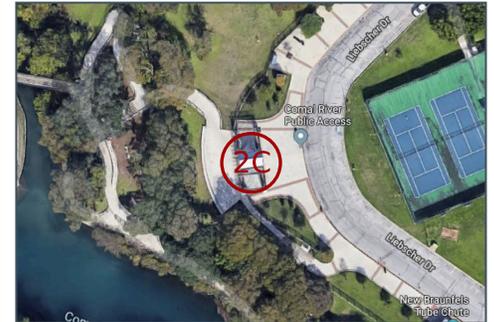
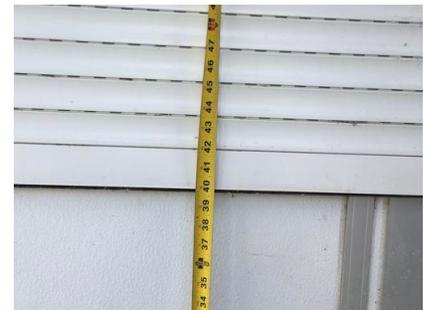
3

The cash and credit counters on each side are approximately 41 inches high.

Recommendation: Install an accessible counter on each side that is no higher than 36 inches and at least 36 inches wide.

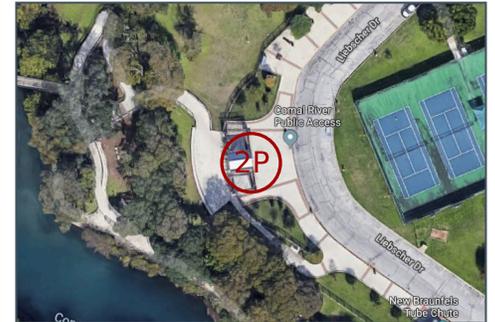
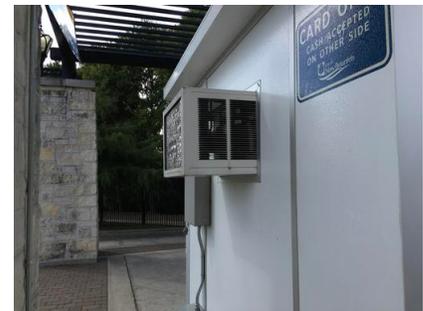
3

The A/C unit on the east side of the booth projects approximately 13 inches at a height of 64 inches.

Recommendation: Install some type of cane barrier below (bollards, railing, etc.).

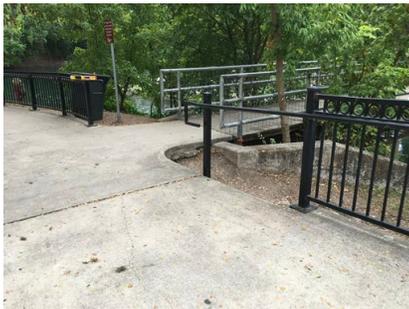
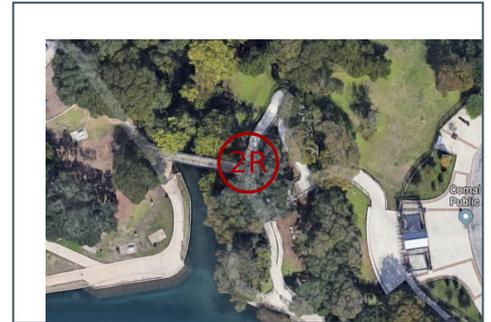
3

The bottom 5 feet of ramp near the bridge lacks edge protection one side.

Recommendation: Extend bottom railing for 5 feet.

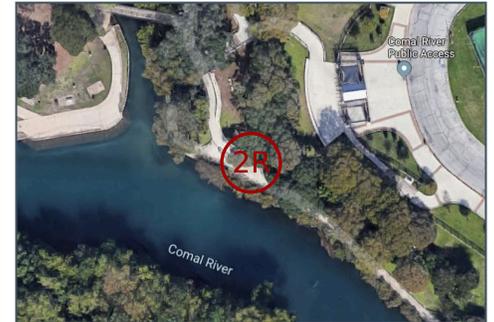
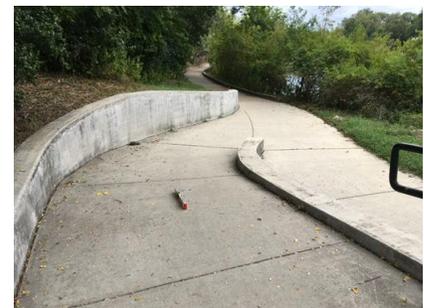
3

The bottom 18 feet of sidewalk has a running slope of approximately 7%, and no handrails are provided. (Note: The sidewalk above this point has a running slope of 5% or less and does not require handrails.)

Recommendation: Add handrails on both sides with minimum 12-inch extensions at the bottom and top (approximately 40 l.f.).

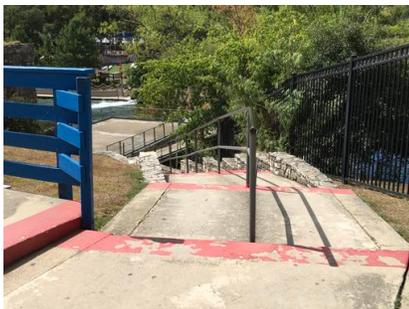
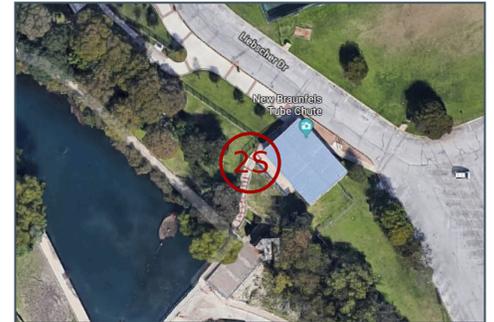
3

The main route from the Tube Chute Building to the river is not accessible. No sign is provided that directs users to the accessible route.

Recommendation: Add a sign with the International Symbol of Accessibility that directs guests to the location of the accessible route via the Gateway.

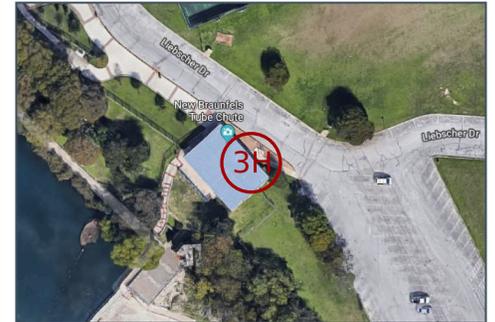
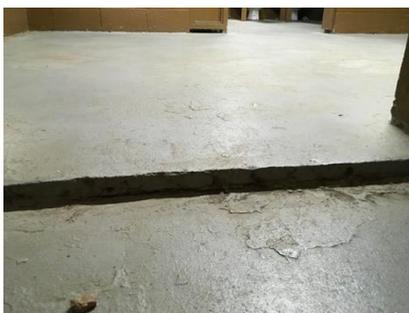
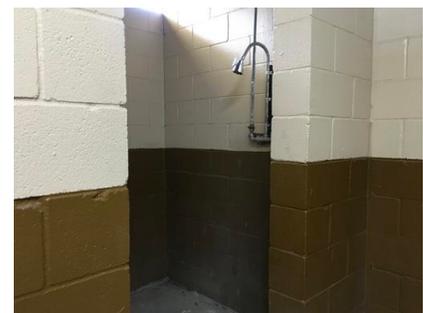
3

No accessible shower is provided. Existing showers measure approximately 86 inches wide and 66 inches deep. There is an approximate 1- to 2-inch change in level at the opening.

Reconfigure showers to provide a new accessible roll-in or transfer shower. Ensure a maximum 1/2-inch threshold.

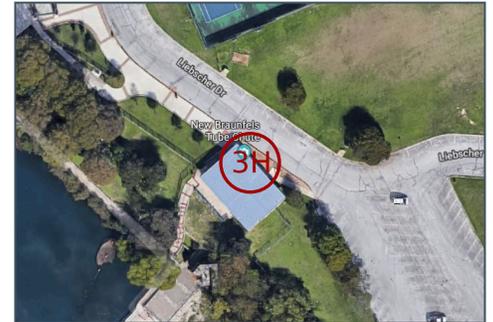
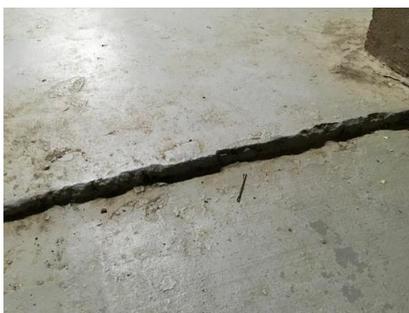
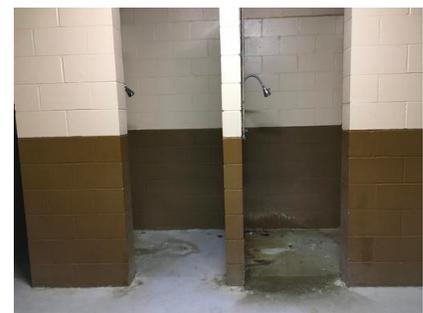
3

No accessible shower is provided. Existing showers measure approximately 46 inches wide and 50 inches deep. There is an approximate 1-inch change in level at the opening.

Reconfigure showers to provide a new accessible roll-in or transfer shower. Ensure a maximum 1/2-inch threshold.

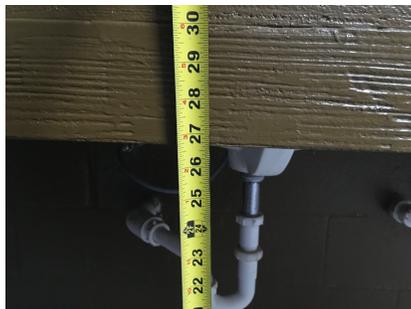
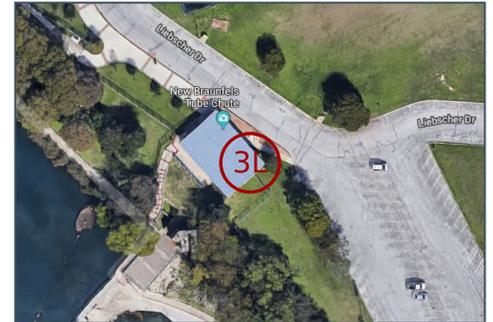
3

The accessible lavatory does not have drainpipe insulation.

(Note: The knee space height measures approximately 26 3/4 inches high. A minimum clearance of 27 inches is required, but we feel that this is within reasonable tolerance.)

Recommendation: Install a pipe wrap insulation kit.
