# CITY OF SAN MARCOS ADA TRANSITION PLAN SIGNALIZED INTERSECTION ASSESSMENT AND COMPLIANCE REPORT

Location ID: 0000000103  
 North-South Cross Street: HUNTER RD  
 East-West Cross Street: STAGECOACH TR

North-South Cross Street: HUNTER RD

East-West Cross Street: STAGECOACH TR

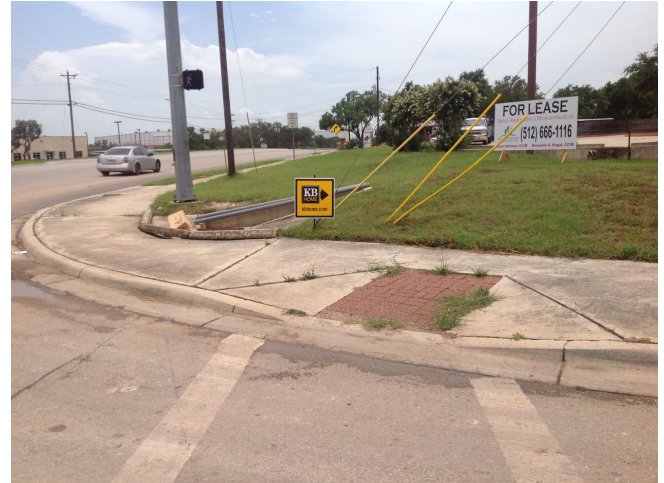
<b>Ramp Elements</b>	Curb ramp provided where an accessible route crosses a barrier:	YES
	Is the slope of the ramp 1:12 or less:	NO
	Transition from curb ramp slope to roadway free from abrupt changes, no greater than 1:20:	YES
	Ramp is at least 36" wide:	YES
	Ramp surface is stable, firm, and slip resistant:	YES
<b>Flare</b>	Flares (if present) are 1:10 or less measured along the curb line; or If landing at top of ramp is not provided flares are 1:12 or less:	
<b>Detectable Warning Surface</b>	Curb ramp is located such that it does not project into roadway or parking aisles:	N/A
	Detectable warning is present:	YES
	DWS maintains correct geometric controls; 0.9" diameter domes, 0.2" in height, spaced at 2.35" and visually contrasts adjacent ramp surface:	YES
<b>Special Ramps</b>	Ramp maintains defined edges parallel to direction of pedestrian travel; maintains 4'x4' turning pad contained in crosswalk; flared sides 24" segment on each side of ramp within crosswalk lines:	YES

Ramp is located so they will not be obstructed by parked vehicles:	N/A
	Ramp wholly contained within the crosswalk lines:	YES
	If island is present; Island maintains a cut through at street level or ramps on either side with landing between them:	N/A
