CITY OF SAN MARCOS ADA TRANSITION PLAN SIGNALIZED INTERSECTION ASSESSMENT AND COMPLIANCE REPORT

Location ID: 0000000163
 North-South Cross Street: THORPE LN
 East-West Cross Street: EASTWOOD ST

Date of Evaluation: 6/27/2014

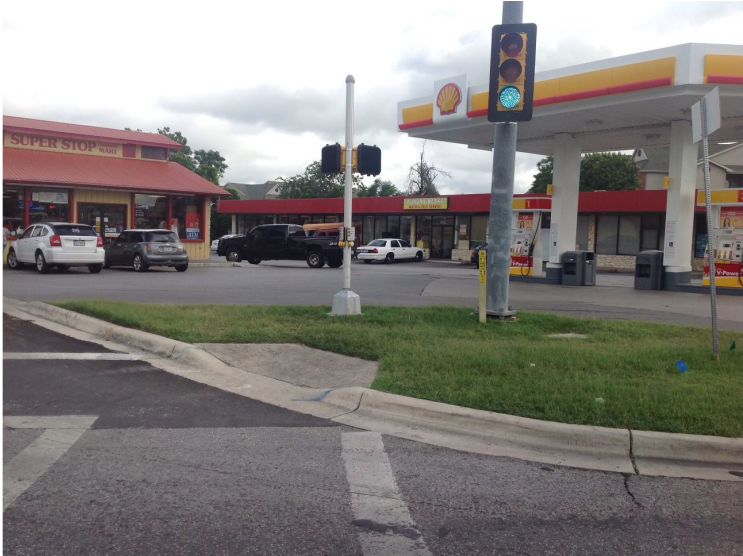
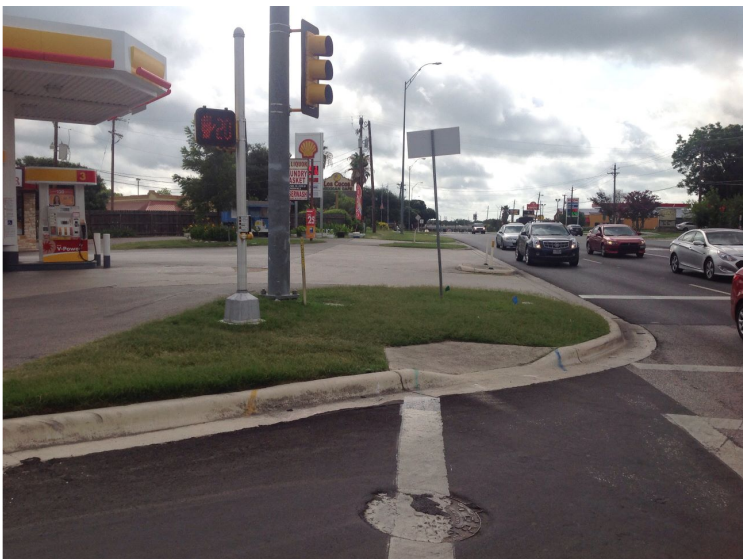
Location Photos

Ramp Elements	Curb ramp provided where an accessible route crosses a barrier:	YES
	Is the slope of the ramp 1:12 or less:	NO
	Transition from curb ramp slope to roadway free from abrupt changes, no greater than 1:20:	NO
	Ramp is at least 36" wide:	NO
	Ramp surface is stable, firm, and slip resistant:	YES
Flare	Flares (if present) are 1:10 or less measured along the curb line; or If landing at top of ramp is not provided flares are 1:12 or less:	NO
Detectable Warning Surface	Curb ramp is located such that it does not project into roadway or parking aisles:	N/A
	Detectable warning is present:	NO
	DWS maintains correct geometric controls; 0.9" diameter domes, 0.2" in height, spaced at 2.35" and visually contracts adjacent ramp surface:	NO
Special Ramps	Ramp maintains defined edges parallel to direction of pedestrian travel; maintains 4'x4' turning pad contained in crosswalk; flared sides 24" segment on each side of ramp within crosswalk lines:	YES
