# CITY OF SAN MARCOS ADA TRANSITION PLAN SIGNALIZED INTERSECTION ASSESSMENT AND COMPLIANCE REPORT

Location ID: 0000000267  
 North-South Cross Street: SAN ANTONIO ST  
 East-West Cross Street: GUADALUPE ST

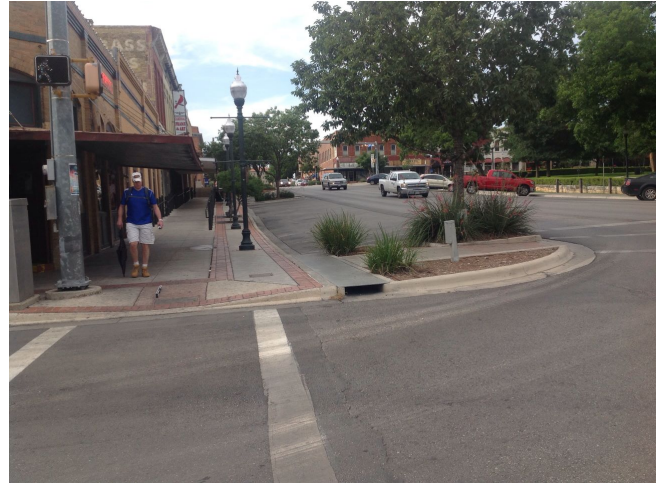
<b>Ramp Elements</b>	Curb ramp provided where an accessible route crosses a barrier:	YES
	Is the slope of the ramp 1:12 or less:	YES
	Transition from curb ramp slope to roadway free from abrupt changes, no greater than 1:20:	NO
	Ramp is at least 36" wide:	YES
	Ramp surface is stable, firm, and slip resistant:	YES
<b>Flare</b>	Flares (if present) are 1:10 or less measured along the curb line; or If landing at top of ramp is not provided flares are 1:12 or less:	YES
<b>Detectable Warning Surface</b>	Curb ramp is located such that it does not project into roadway or parking aisles:	YES
	Detectable warning is present:	NO
	DWS maintains correct geometric controls; 0.9" diameter domes, 0.2" in height, spaced at 2.35" and visually contracts adjacent ramp surface:	NO
<b>Special Ramps</b>	Ramp maintains defined edges parallel to direction of pedestrian travel; maintains 4'x4' turning pad contained in crosswalk; flared sides 24" segment on each side of ramp within crosswalk lines:	N/A

Ramp is located so they will not be obstructed by parked vehicles:	YES
	Ramp wholly contained within the crosswalk lines:	YES
	If island is present; Island maintains a cut through at street level or ramps on either side with landing between them:	N/A
