**CITY OF SAN MARCOS
ADA TRANSITION PLAN
SIGNALIZED INTERSECTION ASSESSMENT
AND COMPLIANCE REPORT**

Location ID: 0000000281
 North-South Cross Street: SESSOM DR
 East-West Cross Street: LBJ DR

Date of Evaluation: 6/27/2014

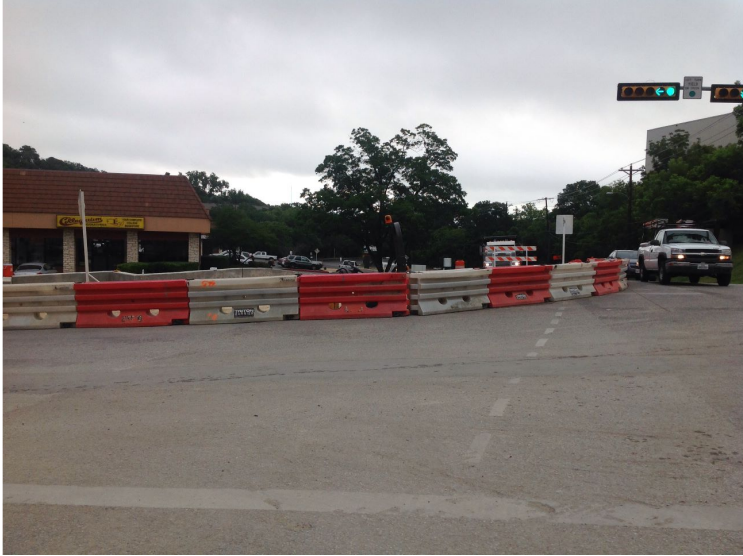
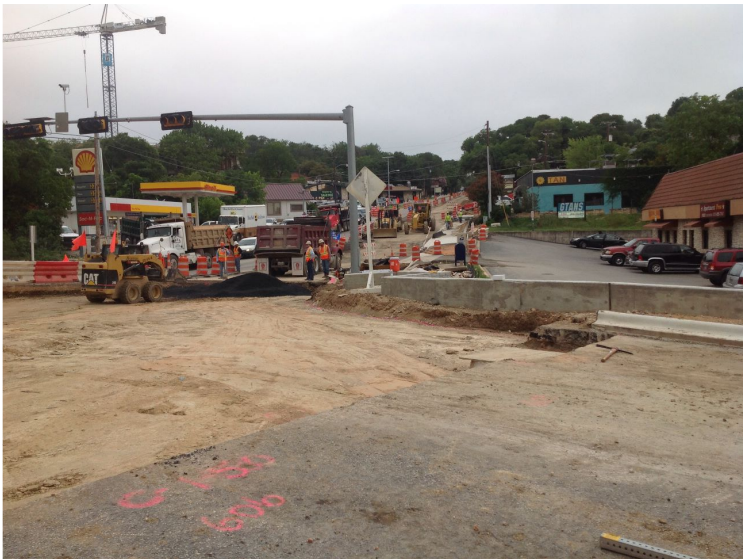
Location Photos

Ramp Elements	Curb ramp provided where an accessible route crosses a barrier:	NO
	Is the slope of the ramp 1:12 or less:	NO
	Transition from curb ramp slope to roadway free from abrupt changes, no greater than 1:20:	NO
	Ramp is at least 36" wide:	NO
	Ramp surface is stable, firm, and slip resistant:	NO
Flare	Flares (if present) are 1:10 or less measured along the curb line; or If landing at top of ramp is not provided flares are 1:12 or less:	NO
Detectable Warning Surface	Curb ramp is located such that it does not project into roadway or parking aisles:	N/A
	Detectable warning is present:	NO
	DWS maintains correct geometric controls; 0.9" diameter domes, 0.2" in height, spaced at 2.35" and visually contracts adjacent ramp surface:	NO
Special Ramps	Ramp maintains defined edges parallel to direction of pedestrian travel; maintains 4'x4' turning pad contained in crosswalk; flared sides 24" segment on each side of ramp within crosswalk lines:	N/A
