Utility Conflict Report

| OWNER | Utility | CPS | Corridor | NOGALITOS | SITE PHOTOS | | |
| | Contact | JAKE MARTINEZ | ID | 3032 | | | |

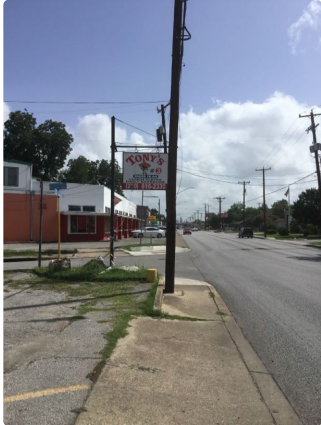
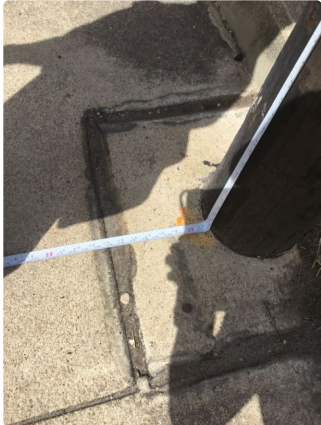
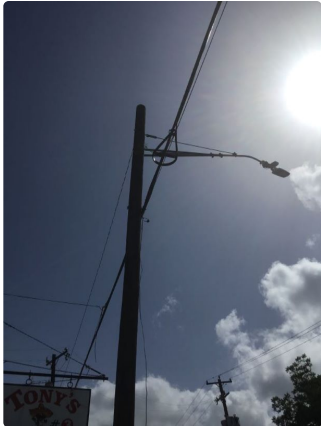
| GENERAL INFO | Utility | ELECTRIC | | | | | |
| | Size and Material | STANDARD POWER POLE, TIMBER | | | | | |
| | Accessible Route | ASSET IS INSIDE ACCESSIBLE ROUTE | | | | | |
| | Longitudinal or Crossing | CROSSING | | | | | |
| | Placement Relative to ROW | INSIDE ROW | | | | | |
| | Comment | Pole ID: LW 57272; PL 386750 Pole to back of curb = 3'-2" Pole to face of wall = 2" | | | | | |

| RESOLUTION | Recommended Action | MINIMIZE - PROTECT IN PLACE | | | | | |
| | Resolution Status | UTILITY OWNER INFORMED OF UTILITY | | | | | |
