## Utility Conflict Report

| <b>OWNER</b> | <b>Utility</b> | CPS | <b>Corridor</b> | NOGALITOS | <b>SITE PHOTOS</b> |
| | <b>Contact</b> | JAKE MARTINEZ | <b>ID</b> | 3063 | |

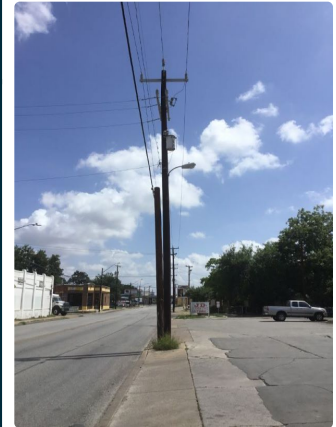
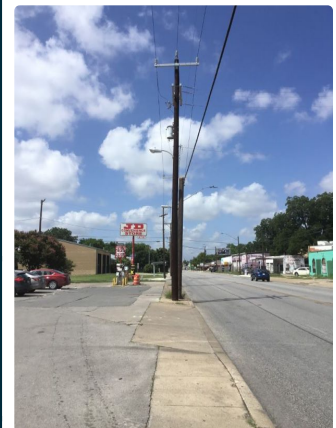
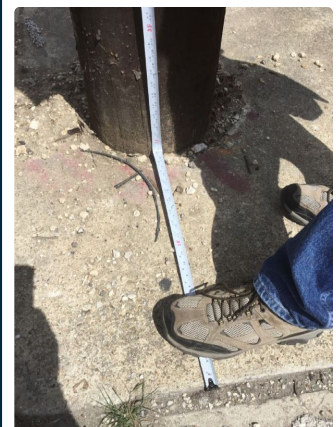
| | <b>Size and Material</b> | STANDARD POWER POLE, TIMBER | | | |
| | <b>Accessible Route</b> | ASSET IS INSIDE ACCESSIBLE ROUTE | | | |
| | <b>Comment</b> | Pole to back of sidewalk = 1'-11"<br>Pole to back of curb = 1'-9"<br>Sidewalk width = 4'-9"<br>Pole diameter = 13"<br>No pole ID | | | |

| <b>RESOLUTION</b> | <b>Recommended Action</b> | MINIMIZE - PROTECT IN PLACE | | | |
