Utility Conflict Report

OWNER	Utility	SAWS	Corridor	SW MILITARY	SITE PHOTOS		
	Contact	ANN PECHE	ID	3114			
GENERAL INFO	Utility	WATER

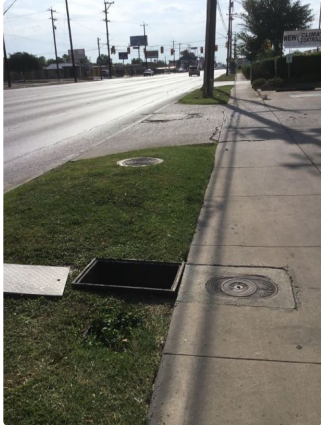
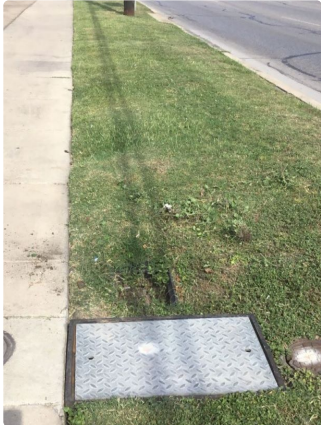
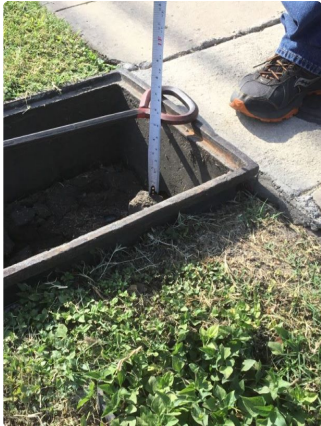
Size and Material	STANDARD WATER METER, CAST IRON					
	Accessible Route	ASSET IS INSIDE ACCESSIBLE ROUTE					
	Longitudinal or Crossing	CROSSING					
	Placement Relative to ROW	INSIDE ROW					
LOCATION	Sheet No.	134

Comment	Top of meter to surface = 6" Lid thickness = 3/8" Sidewalk width = 4'-5" Abandoned utility box located next to meter box					
Date Collected		7/24/2018 9:41:41 AM		Date Modified		12/17/2018 10:47:26 AM

Test Hole No	N/A					
	Test Hole Depth	N/A					
RESOLUTION	Recommended Action	MINIMIZE - PROTECT IN PLACE					
	Estimated Resolution Date						
	Resolution Status	UTILITY OWNER INFORMED OF UTILITY
