Utility Conflict Report

OWNER	Utility	SAWS	Corridor	SW MILITARY	SITE PHOTOS		
	Contact	ANN PECHE	ID	3123			
GENERAL INFO	Utility	WATER

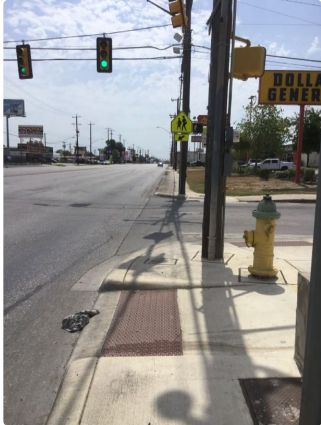
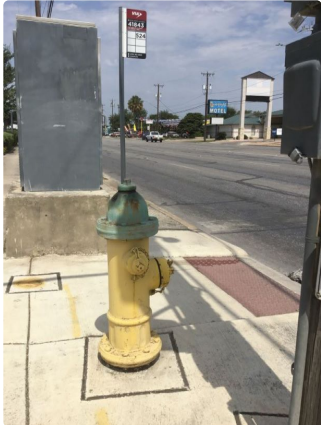
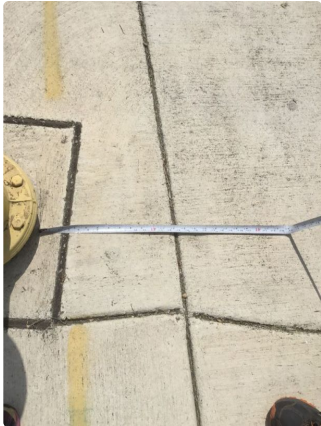
Size and Material	STANDARD FIRE HYDRANT					
	Accessible Route	ASSET IS INSIDE ACCESSIBLE ROUTE					
	Longitudinal or Crossing	CROSSING					
	Placement Relative to ROW	INSIDE ROW					
LOCATION	Sheet No.	135

Test Hole No	N/A					
	Test Hole Depth	N/A					
RESOLUTION	Recommended Action	NO CONFLICT					
	Estimated Resolution Date						
	Resolution Status	NO RESOLUTION WAS REQUIRED					
	Comment	Back of curb to hydrant = 4'-10" Sidewalk width = 4'-10" Front of sidewalk to hydrant = 1'-2"					
Date Collected		7/24/2018 11:32:24 AM		Date Modified		11/28/2018 6:59:12 AM
