## Utility Conflict Report

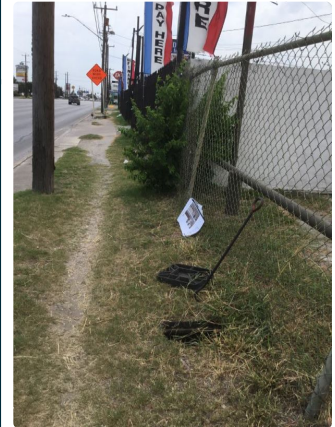
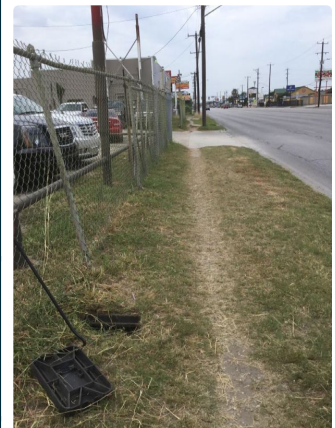
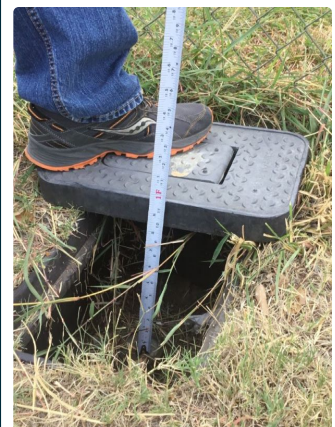
<b>OWNER</b>	<b>Utility</b>	SAWS	<b>Corridor</b>	SW MILITARY	<b>SITE PHOTOS</b>		
	<b>Contact</b>	ANN PECHE	<b>ID</b>	3136			
<b>GENERAL INFO</b>	<b>Utility</b>	WATER					
	<b>Size and Material</b>	STANDARD WATER METER, STEEL					
	<b>Accessible Route</b>	ASSET IS INSIDE ACCESSIBLE ROUTE					
	<b>Longitudinal or Crossing</b>	CROSSING					
	<b>Placement Relative to ROW</b>	INSIDE ROW					
<b>LOCATION</b>	<b>Sheet No.</b>						
	<b>Station</b>	555+89.87					
	<b>Offset</b>	20.6794					
	<b>Latitude</b>	+29.357402					
	<b>Longitude</b>	-98.55226					
<b>SUE</b>	<b>Level of Investigation Req'd</b>	NONE					
	<b>Test Hole No</b>	N/A					
	<b>Test Hole Depth</b>	N/A					
<b>RESOLUTION</b>	<b>Recommended Action</b>	NO CONFLICT					
	<b>Estimated Resolution Date</b>						
	<b>Resolution Status</b>	NO RESOLUTION WAS REQUIRED					
	<b>Comment</b>	Top of meter to surface = 9" Lid thickness = 1 3/4" Back of curb to meter = 7'-10" Fence to meter = 8"
