Utility Conflict Report

OWNER	Utility	CPS	Corridor	NOGALITOS	SITE PHOTOS		
	Contact	JAKE MARTINEZ	ID	4008			
GENERAL INFO	Utility	GAS

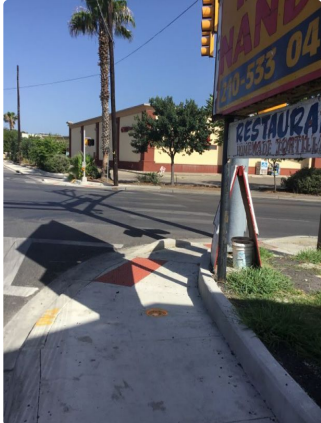
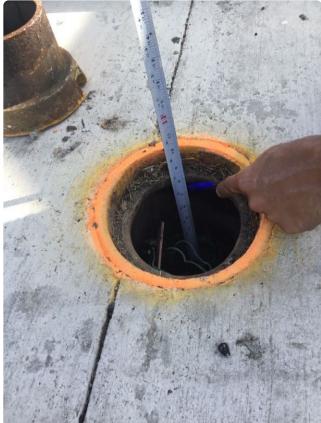
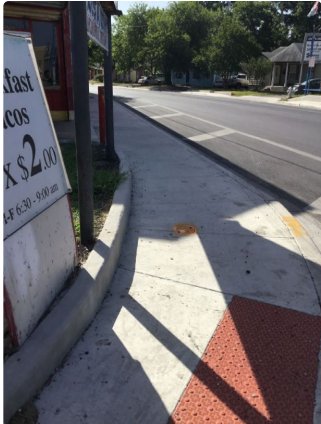
Size and Material	STANDARD GAS VALVE, CAST IRON					
	Accessible Route	ASSET IS INSIDE ACCESSIBLE ROUTE					
	Longitudinal or Crossing	CROSSING					
	Placement Relative to ROW	INSIDE ROW					
LOCATION	Sheet No.

Test Hole No	N/A					
	Test Hole Depth	N/A					
RESOLUTION	Recommended Action	NO CONFLICT					
	Estimated Resolution Date	8/13/2018					
	Resolution Status	NO RESOLUTION WAS REQUIRED					
	Comment	Lid thickness = 1 5/8" Top of valve to surface = 10" Top of valve to lid lip = 7.5" Valve to back of wall = 1'-6"					
Date Collected		7/2/2018 10:00:28 AM		Date Modified		8/14/2018 4:38:26 PM
