Utility Conflict Report

OWNER	Utility	PRIVATE	Corridor	SW MILITARY	SITE PHOTOS		
	Contact	UNKNOWN	ID	4133			
GENERAL INFO	Utility	UNKNOWN

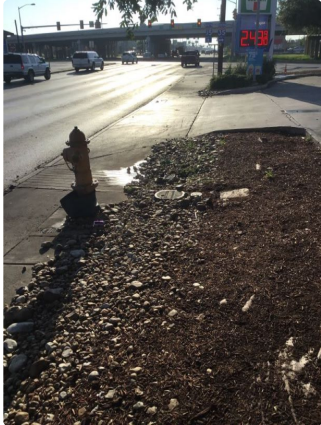
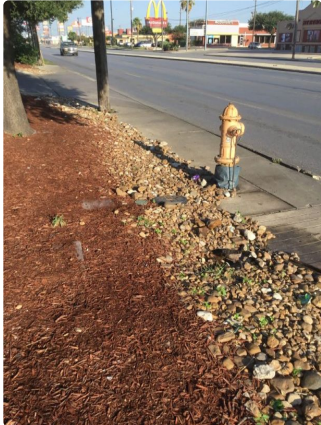
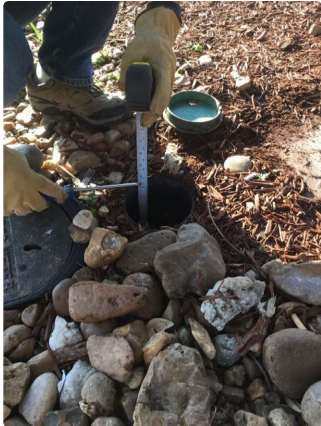
Size and Material	IRRIGATION VALVE					
	Accessible Route	ASSET IS OUTSIDE ACCESSIBLE ROUTE					
	Longitudinal or Crossing	CROSSING					
	Placement Relative to ROW	INSIDE ROW					
LOCATION	Sheet No.	148

Test Hole No	N/A					
	Test Hole Depth	N/A					
RESOLUTION	Recommended Action	NO CONFLICT					
	Estimated Resolution Date						
	Resolution Status	NO RESOLUTION WAS REQUIRED					
	Comment	Valve to EOS = 2'-5" Top of valve to surface = 6 1/2" Lid thickness = 1 1/4" Plastic lid					
Date Collected		8/1/2018 8:25:06 AM		Date Modified		11/28/2018 6:59:12 AM
