Utility Conflict Report

| OWNER | Utility | CPS | Corridor | SW MILITARY | SITE PHOTOS | | |
| GENERAL INFO | Utility | ELECTRIC | | | | | |
| | Size and Material | STANDARD POWER POLE, TIMBER | | | | | |

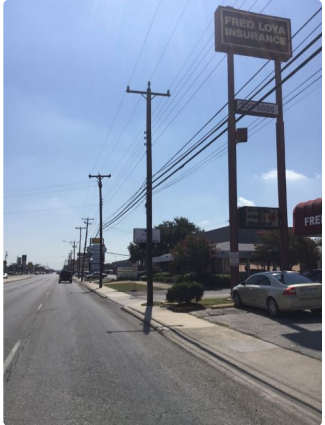
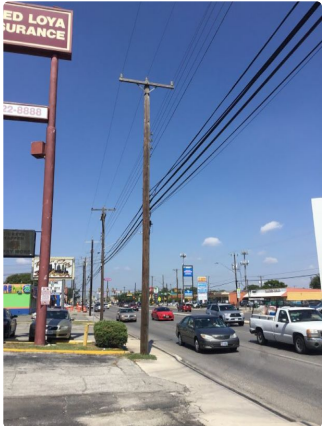
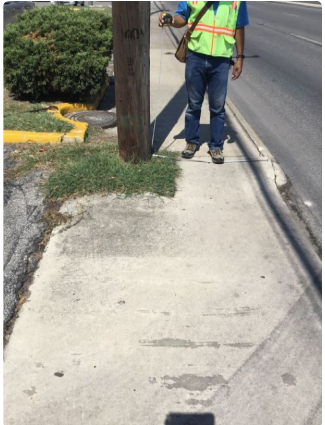
| | Accessible Route | ASSET IS INSIDE ACCESSIBLE ROUTE | | | | | |
| | Comment | Pole ID: 436609 Pole to back of curb = 3'-9" Sidewalk width = 6'-0" Pole to back of sidewalk = 1'-2" | | | | | |

| RESOLUTION | Recommended Action | NO CONFLICT | | | | | |
| | Resolution Status | NO RESOLUTION WAS REQUIRED | | | | | |
