Utility Conflict Report

OWNER	Utility	SAWS	Corridor	SW MILITARY	SITE PHOTOS	
	Contact	ANN PECHE	ID	4203		
GENERAL INFO	Utility	SANITARY SEWER

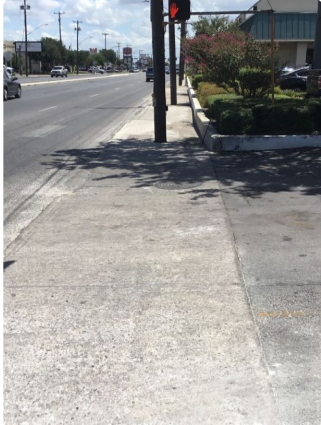
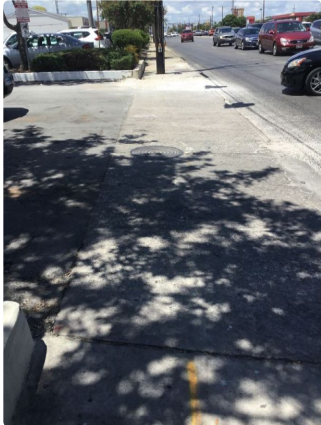
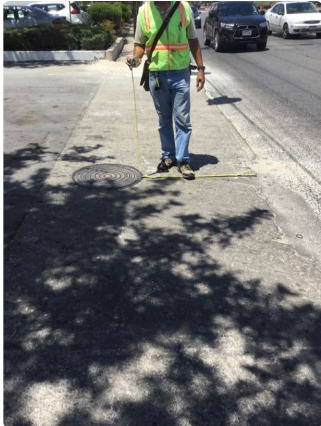
Size and Material	STANDARD MANHOLE, CAST IRON				
	Accessible Route	ASSET IS INSIDE ACCESSIBLE ROUTE				
	Longitudinal or Crossing	CROSSING				
	Placement Relative to ROW	INSIDE ROW				
LOCATION	Sheet No.	162

Station	717+34.48				
	Offset	17.11				
	Latitude	+29.356584				
	Longitude	-98.50159				
SUE	Level of Investigation Req'd	NONE

Test Hole No	N/A				
	Test Hole Depth	N/A				
RESOLUTION	Recommended Action	NO CONFLICT				
	Estimated Resolution Date					
	Resolution Status	NO RESOLUTION WAS REQUIRED				
	Comment	Manhole to back of curb = 3'-9" Manhole to back of driveway apron = 9" Width of driveway apron = 6'-10" Unable to open manhole				
Date Collected		8/6/2018 12:58:03 PM	Date Modified		12/19/2018 9:24:23 AM
