Utility Conflict Report

OWNER	Utility	SAWS	Corridor	BANDERA	SITE PHOTOS	
	Contact	ANN PECHE	ID	4574		
GENERAL INFO	Utility	WATER

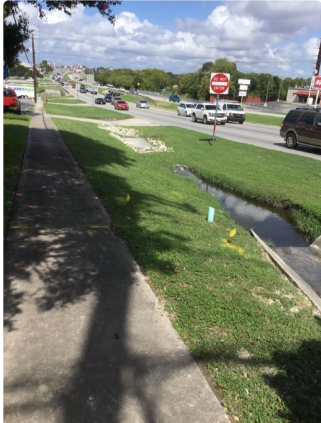
Size and Material	UNKNOWN				
	Accessible Route	ASSET IS INSIDE ACCESSIBLE ROUTE				
	Longitudinal or Crossing	LONGITUDINAL				
	Placement Relative to ROW	INSIDE ROW				
LOCATION	Sheet No.	234

Station	1754+60				
	Offset	-20				
	Latitude	+29.491069				
	Longitude	-98.61324				
SUE	Level of Investigation Req'd	QLA

Estimated Resolution Date					
	Resolution Status	UTILITY OWNER INFORMED OF UTILITY				
	Comment	GIS indicates that a waterline could be located beneath proposed bus pad. Request As-builts for line depth verification				
Date Collected		11/20/2018 9:42:42 AM		Date Modified	12/19/2018 11:48:35 AM

Test Hole No	N/A				
	Test Hole Depth	N/A				
RESOLUTION	Recommended Action	ACCOMODATE - RELOCATION
