Utility Conflict Report

OWNER	Utility	SAWS	Corridor	SW MILITARY	SITE PHOTOS	
	Contact	ANN PECHE	ID	7085		
GENERAL INFO	Utility	WATER

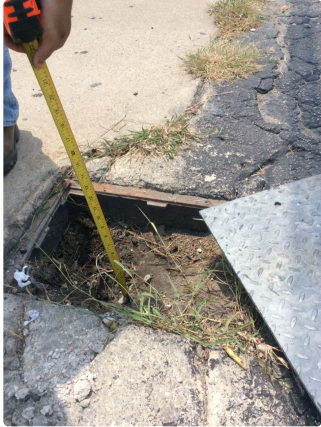
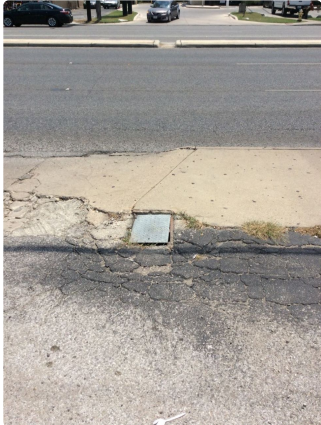
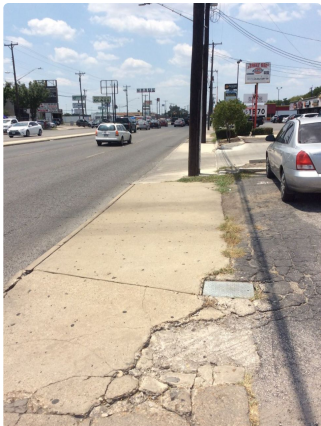
Size and Material	STANDARD WATER METER, STEEL				
	Accessible Route	ASSET IS INSIDE ACCESSIBLE ROUTE				
	Longitudinal or Crossing	CROSSING				
	Placement Relative to ROW	INSIDE ROW

Test Hole No	N/A				
	Test Hole Depth	N/A				
RESOLUTION	Recommended Action	MINIMIZE - PROTECT IN PLACE				
	Estimated Resolution Date					
	Resolution Status	UTILITY OWNER INFORMED OF UTILITY				
	Comment	Meter adjacent to back of sidewalk Meter filled with dirt Top of dirt to surface = 6"				
Date Collected		8/3/2018 2:10:03 PM		Date Modified	12/18/2018 7:57:25 AM
