Utility Conflict Report

OWNER	Utility	SAWS	Corridor	SW MILITARY	SITE PHOTOS	
	Contact	ANN PECHE	ID	7092		
GENERAL INFO	Utility	WATER

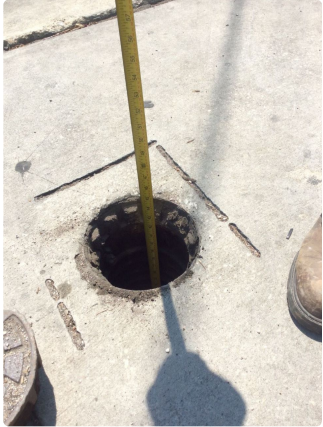
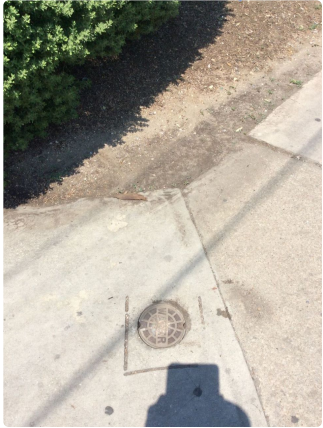
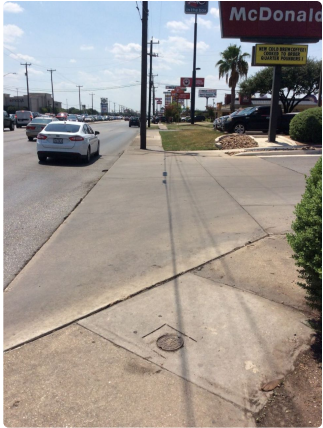
Size and Material	STANDARD WATER VALVE, CAST IRON				
	Accessible Route	ASSET IS INSIDE ACCESSIBLE ROUTE				
	Longitudinal or Crossing	CROSSING				
	Placement Relative to ROW	INSIDE ROW				
LOCATION	Sheet No.	197

Station	863+88.87				
	Offset	-17.43				
	Latitude	+29.356837				
	Longitude	-98.52786				
SUE	Level of Investigation Req'd	NONE

Test Hole No	N/A				
	Test Hole Depth	N/A				
RESOLUTION	Recommended Action	MINIMIZE - PROTECT IN PLACE				
	Estimated Resolution Date					
	Resolution Status	UTILITY OWNER INFORMED OF UTILITY				
	Comment	Valve to back of sidewalk = 2'-4" Top of valve to surface = 3'-8" Lid thickness = 2"				
Date Collected		8/3/2018 3:05:29 PM	Date Modified		11/28/2018 6:59:12 AM
