## Utility Conflict Report

<b>OWNER</b>	<b>Utility</b>	SAWS	<b>Corridor</b>	SW MILITARY	<b>SITE PHOTOS</b>	
	<b>Contact</b>	ANN PECHE	<b>ID</b>	7150		
<b>GENERAL INFO</b>	<b>Utility</b>	WATER

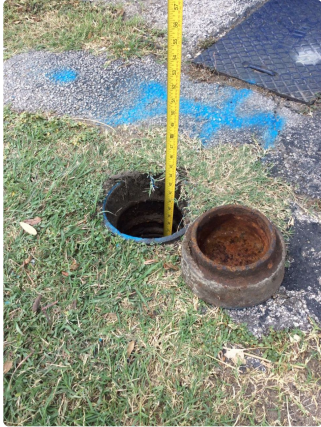
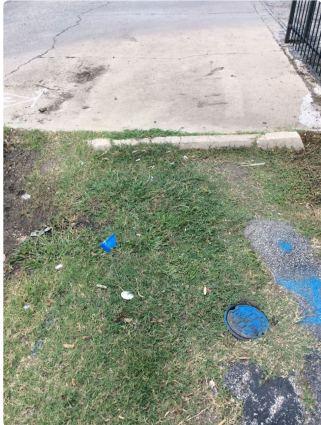
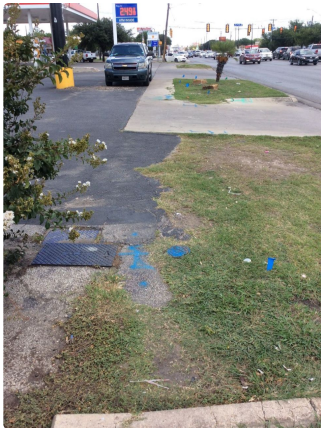
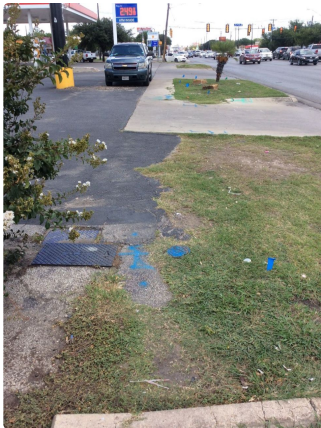
<b>Size and Material</b>	STANDARD WATER VALVE, CAST IRON				
	<b>Accessible Route</b>	ASSET IS INSIDE ACCESSIBLE ROUTE				
	<b>Longitudinal or Crossing</b>	CROSSING				
	<b>Placement Relative to ROW</b>	INSIDE ROW				
<b>LOCATION</b>	<b>Sheet No.</b>	172

<b>Estimated Resolution Date</b>					
	<b>Resolution Status</b>	NO RESOLUTION WAS REQUIRED				
	<b>Comment</b>	Valve near 2 water meters Top of valve to surface = 3'-4" Lid thickness = 2" Edge of driveway to valve = 5'-8"

<b>Test Hole No</b>	N/A				
	<b>Test Hole Depth</b>	N/A				
<b>RESOLUTION</b>	<b>Recommended Action</b>	NO CONFLICT
