Utility Conflict Report

OWNER	Utility	CPS	Corridor	NOGALITOS	SITE PHOTOS		
	Contact	JAKE MARTINEZ	ID	4055			
GENERAL INFO	Utility	ELECTRIC

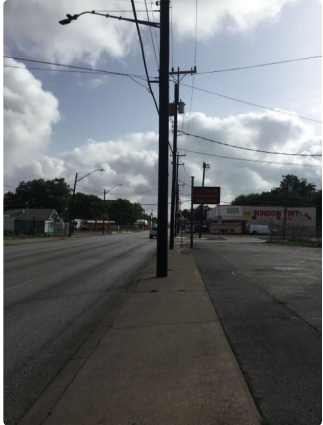
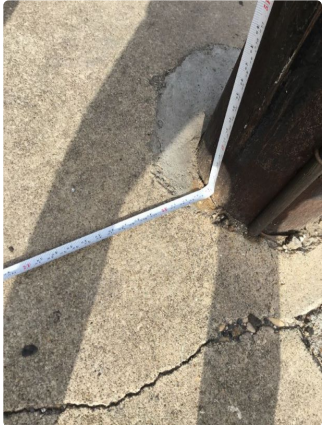
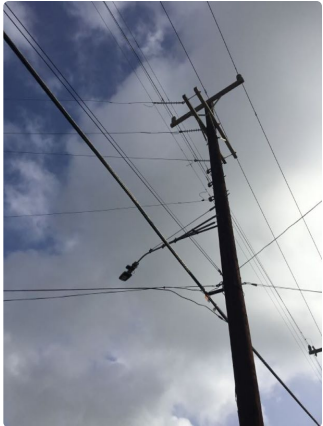
Size and Material	STANDARD POWER POLE, TIMBER					
	Accessible Route	ASSET IS INSIDE ACCESSIBLE ROUTE					
	Longitudinal or Crossing	CROSSING					
	Placement Relative to ROW	INSIDE ROW					
LOCATION	Sheet No.	78

Station	122+61.53					
	Offset	23.01					
	Latitude	+29.391068					
	Longitude	-98.51994					
SUE	Level of Investigation Req'd	NONE

Test Hole No	N/A					
	Test Hole Depth	N/A					
RESOLUTION	Recommended Action	MINIMIZE - PROTECT IN PLACE					
	Estimated Resolution Date						
	Resolution Status	UTILITY OWNER INFORMED OF UTILITY					
	Comment	Pole ID: LW 474993; PL 461514 Pole to back of sidewalk = 3'-5"					
Date Collected		7/10/2018 8:43:25 AM		Date Modified		9/13/2018 2:01:26 PM
