**CITY OF SAN MARCOS  
ADA TRANSITION PLAN  
SIGNALIZED INTERSECTION ASSESSMENT  
AND COMPLIANCE REPORT**

Location ID: 000000071  
 North-South Cross Street: MCCARTY LN  
 East-West Cross Street: MCCARTY LN

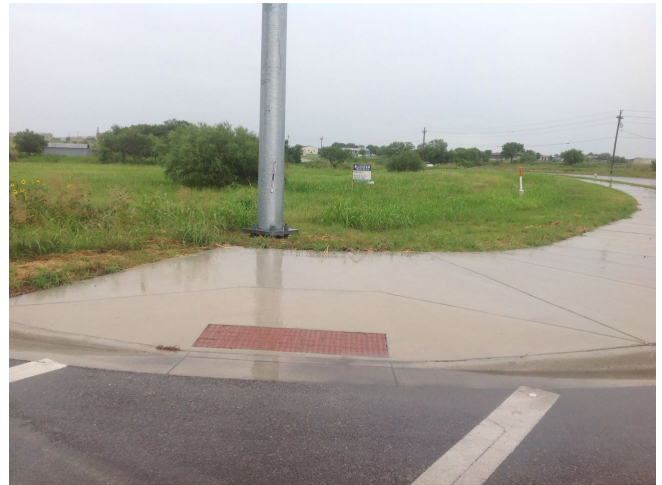
Signalized Intersection: YES  
 Accessible Features: NO  
 Pedestrian Features Accessible: NO

<b>Ramp Elements</b>	Curb ramp provided where an accessible route crosses a barrier:	YES
	Is the slope of the ramp 1:12 or less:	YES
	Transition from curb ramp slope to roadway free from abrupt changes, no greater than 1:20:	YES
	Ramp is at least 36" wide:	YES
	Ramp surface is stable, firm, and slip resistant:	YES
<b>Flare</b>	Flares (if present) are 1:10 or less measured along the curb line; or If landing at top of ramp is not provided flares are 1:12 or less:	YES
<b>Detectable Warning Surface</b>	Curb ramp is located such that it does not project into roadway or parking aisles:	N/A
	Detectable warning is present:	YES
	DWS maintains correct geometric controls; 0.9" diameter domes, 0.2" in height, spaced at 2.35" and visually contracts adjacent ramp surface:	YES
<b>Special Ramps</b>	Ramp maintains defined edges parallel to direction of pedestrian travel; maintains 4'x4' turning pad contained in crosswalk; flared sides 24" segment on each side of ramp within crosswalk lines:	YES

Ramp is located so they will not be obstructed by parked vehicles:	N/A
	Ramp wholly contained within the crosswalk lines:	YES
	If island is present; Island maintains a cut through at street level or ramps on either side with landing between them:	N/A
