CITY OF SAN MARCOS ADA TRANSITION PLAN

SIGNALIZED INTERSECTION ASSESSMENT AND COMPLIANCE REPORT

North-South Cross Street: LEAH AVE

East-West Cross Street: WONDER WORLD DR

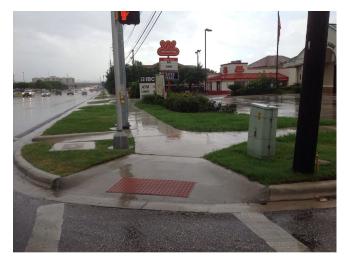
Signalized Intersection: YES Accessible Features: YES

Pedestrian Features Accessible: YES

Ramp Elements	Curb ramp provided where an accessible route crosses a barrier:	YES
	Is the slope of the ramp 1:12 or less:	YES
	Transition from curb ramp slope to roadway free from abrupt changes, no greater than 1:20:	YES
	Ramp is at least 36" wide:	YES
	Ramp surface is stable, firm, and slip resistant:	YES
Flare	Flares (if present) are 1:10 or less measured along the curb line; or If landing at top of ramp is not provided flares are 1:12 or less:	N/A
Detectable Warning Surface	Curb ramp is located such that it does not project into roadway or parking aisles:	N/A
	Detectable warning is present:	YES
	DWS maintains correct geometric controls; 0.9" diameter domes, 0.2" in height, spaced at 2.35" and visually contracts adjacent ramp surface:	YES
Special Ramps	Ramp maintains defined edges parallel to direction of pedestrian travel; maintains 4'x4' turning pad contained in crosswalk; flared sides 24" segment on each side of ramp within crosswalk lines:	N/A

Ramp is located so they will not be obstructed by parked vehicles:	N/A
	Ramp wholly contained within the crosswalk lines:	YES
	If island is present; Island maintains a cut through at street level or ramps on either side with landing between them:	N/A
