CITY OF SAN MARCOS ADA TRANSITION PLAN SIGNALIZED INTERSECTION ASSESSMENT AND COMPLIANCE REPORT

Location ID: 0000000086
 North-South Cross Street: IH 35 SBFR
 East-West Cross Street: SH 123

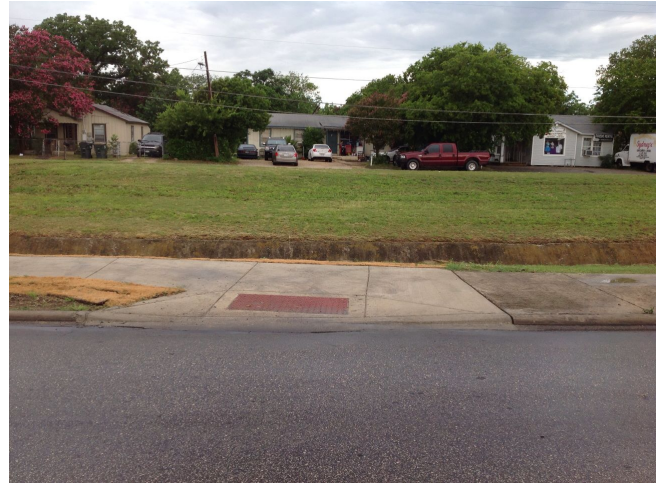
Signalized Intersection: YES
 Accessible Features: NO
 Pedestrian Features Accessible: NO

Ramp Elements	Curb ramp provided where an accessible route crosses a barrier:	YES
	Is the slope of the ramp 1:12 or less:	YES
	Transition from curb ramp slope to roadway free from abrupt changes, no greater than 1:20:	YES
	Ramp is at least 36" wide:	YES
	Ramp surface is stable, firm, and slip resistant:	YES
Flare	Flares (if present) are 1:10 or less measured along the curb line; or If landing at top of ramp is not provided flares are 1:12 or less:	YES
Detectable Warning Surface	Curb ramp is located such that it does not project into roadway or parking aisles:	N/A
	Detectable warning is present:	YES
	DWS maintains correct geometric controls; 0.9" diameter domes, 0.2" in height, spaced at 2.35" and visually contracts adjacent ramp surface:	YES
Special Ramps	Ramp maintains defined edges parallel to direction of pedestrian travel; maintains 4'x4' turning pad contained in crosswalk; flared sides 24" segment on each side of ramp within crosswalk lines:	N/A

Ramp is located so they will not be obstructed by parked vehicles:	N/A
	Ramp wholly contained within the crosswalk lines:	N/A
	If island is present; Island maintains a cut through at street level or ramps on either side with landing between them:	N/A
