CITY OF SAN MARCOS ADA TRANSITION PLAN SIGNALIZED INTERSECTION ASSESSMENT AND COMPLIANCE REPORT

Location ID: 000000089
 North-South Cross Street: GUADALUPE ST
 East-West Cross Street: LOVE ST

Signalized Intersection: YES
 Accessible Features: NO
 Pedestrian Features Accessible: NO

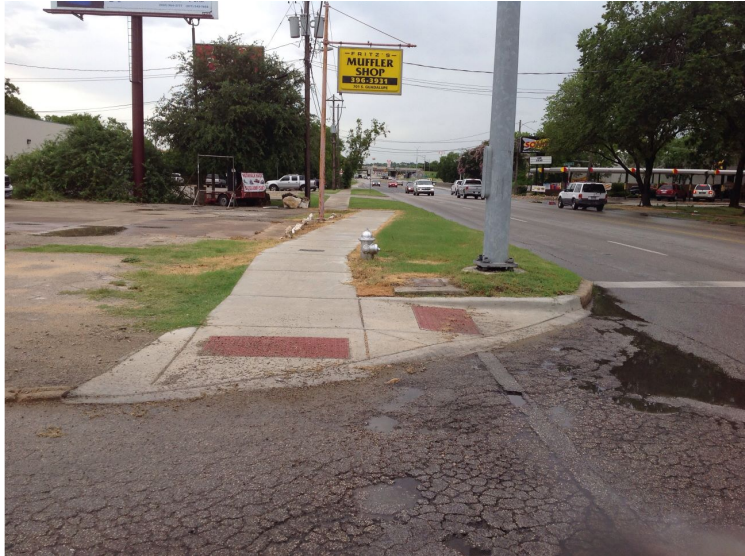
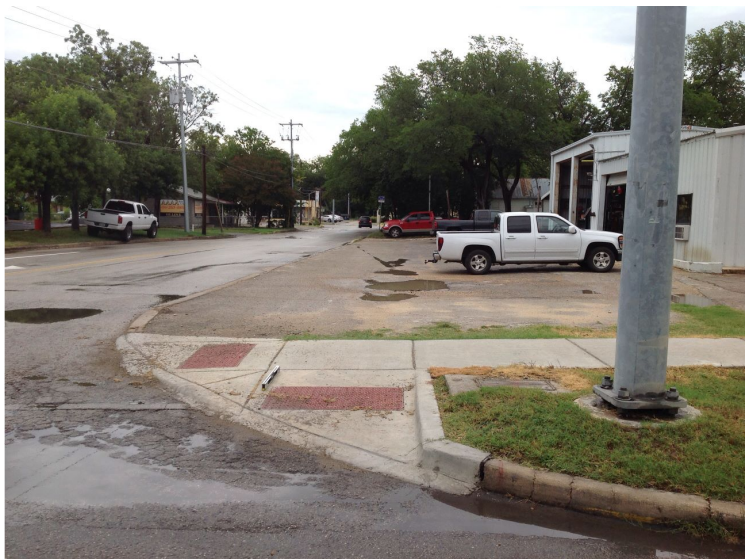
Location Photos

Ramp Elements	Curb ramp provided where an accessible route crosses a barrier:	YES
	Is the slope of the ramp 1:12 or less:	YES
	Transition from curb ramp slope to roadway free from abrupt changes, no greater than 1:20:	YES
	Ramp is at least 36" wide:	YES
	Ramp surface is stable, firm, and slip resistant:	YES
Flare	Flares (if present) are 1:10 or less measured along the curb line; or If landing at top of ramp is not provided flares are 1:12 or less:	YES
Detectable Warning Surface	Curb ramp is located such that it does not project into roadway or parking aisles:	N/A
	Detectable warning is present:	YES
	DWS maintains correct geometric controls; 0.9" diameter domes, 0.2" in height, spaced at 2.35" and visually contrasts adjacent ramp surface:	YES
Special Ramps	Ramp maintains defined edges parallel to direction of pedestrian travel; maintains 4'x4' turning pad contained in crosswalk; flared sides 24" segment on each side of ramp within crosswalk lines:	N/A

Ramp is located so they will not be obstructed by parked vehicles:	N/A
	Ramp wholly contained within the crosswalk lines:	N/A
	If island is present; Island maintains a cut through at street level or ramps on either side with landing between them:	N/A
