**CITY OF SAN MARCOS
ADA TRANSITION PLAN
SIGNALIZED INTERSECTION ASSESSMENT
AND COMPLIANCE REPORT**

Location ID: 0000000100
 North-South Cross Street: HUNTER RD
 East-West Cross Street: WONDER WORLD DR

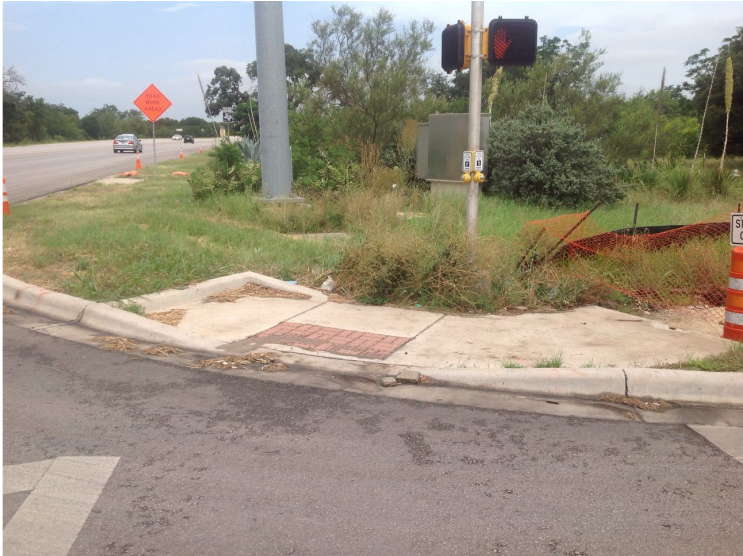
Location Photos

Ramp Elements	Curb ramp provided where an accessible route crosses a barrier:	YES
	Is the slope of the ramp 1:12 or less:	YES
	Transition from curb ramp slope to roadway free from abrupt changes, no greater than 1:20:	YES
	Ramp is at least 36" wide:	YES
	Ramp surface is stable, firm, and slip resistant:	NO
Flare	Flares (if present) are 1:10 or less measured along the curb line; or If landing at top of ramp is not provided flares are 1:12 or less:	YES
Detectable Warning Surface	Curb ramp is located such that it does not project into roadway or parking aisles:	N/A
	Detectable warning is present:	YES
	DWS maintains correct geometric controls; 0.9" diameter domes, 0.2" in height, spaced at 2.35" and visually contracts adjacent ramp surface:	YES
Special Ramps	Ramp maintains defined edges parallel to direction of pedestrian travel; maintains 4'x4' turning pad contained in crosswalk; flared sides 24" segment on each side of ramp within crosswalk lines:	YES

Ramp is located so they will not be obstructed by parked vehicles:	N/A
	Ramp wholly contained within the crosswalk lines:	YES
	If island is present; Island maintains a cut through at street level or ramps on either side with landing between them:	N/A
