**CITY OF SAN MARCOS
ADA TRANSITION PLAN
SIGNALIZED INTERSECTION ASSESSMENT
AND COMPLIANCE REPORT**

Location ID: 0000000101
 North-South Cross Street: STAGECOACH TR
 East-West Cross Street: WONDER WORLD DR

North-South Cross Street: STAGECOACH TR

East-West Cross Street: WONDER WORLD DR

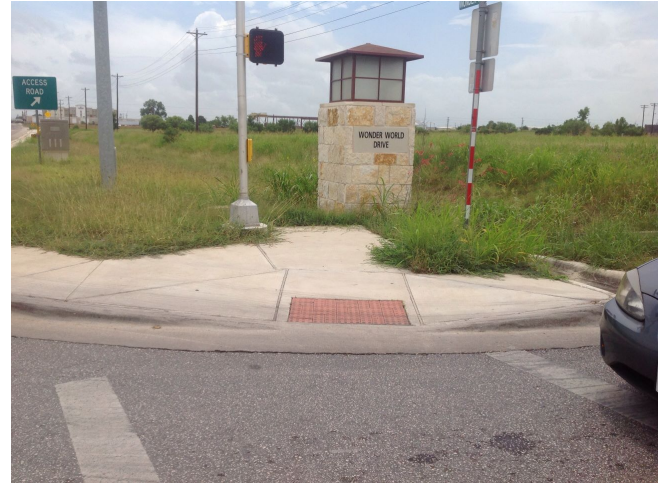
Signalized Intersection: YES
 Accessible Features: YES
 Pedestrian Features Accessible: YES

Ramp Elements	Curb ramp provided where an accessible route crosses a barrier:	YES
	Is the slope of the ramp 1:12 or less:	YES
	Transition from curb ramp slope to roadway free from abrupt changes, no greater than 1:20:	YES
	Ramp is at least 36" wide:	YES
	Ramp surface is stable, firm, and slip resistant:	YES
Flare	Flares (if present) are 1:10 or less measured along the curb line; or If landing at top of ramp is not provided flares are 1:12 or less:	YES
Detectable Warning Surface	Curb ramp is located such that it does not project into roadway or parking aisles:	N/A
	Detectable warning is present:	YES
	DWS maintains correct geometric controls; 0.9" diameter domes, 0.2" in height, spaced at 2.35" and visually contrasts adjacent ramp surface:	YES
Special Ramps	Ramp maintains defined edges parallel to direction of pedestrian travel; maintains 4'x4' turning pad contained in crosswalk; flared sides 24" segment on each side of ramp within crosswalk lines:	N/A

Ramp is located so they will not be obstructed by parked vehicles:	N/A
	Ramp wholly contained within the crosswalk lines:	YES
	If island is present; Island maintains a cut through at street level or ramps on either side with landing between them:	N/A
