**CITY OF SAN MARCOS  
ADA TRANSITION PLAN  
SIGNALIZED INTERSECTION ASSESSMENT  
AND COMPLIANCE REPORT**

Location ID: 0000000105  
 North-South Cross Street: HUNTER RD  
 East-West Cross Street: FOXTAIL RUN

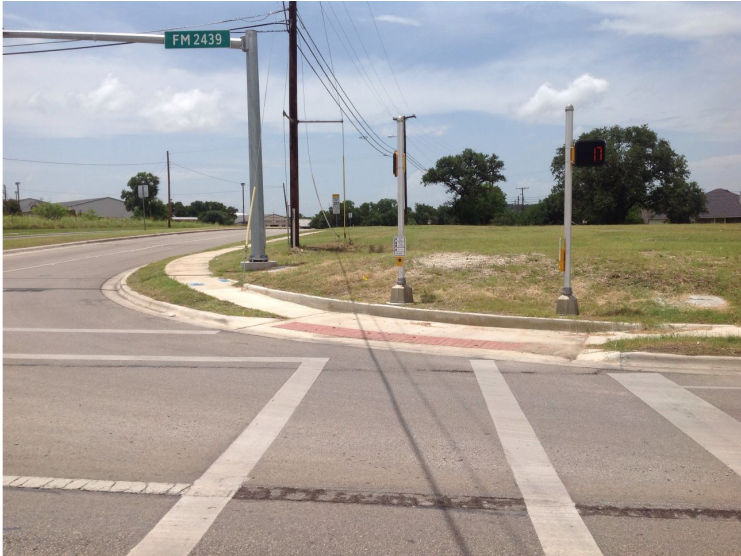
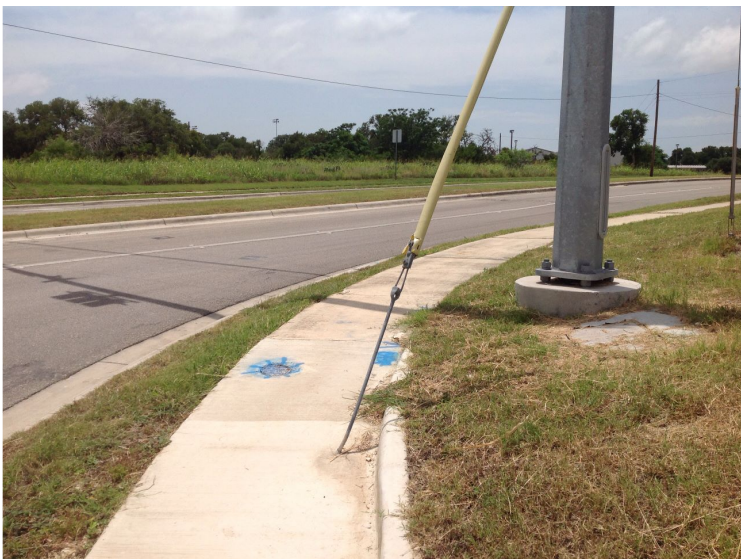
## Location Photos

<b>Ramp Elements</b>	Curb ramp provided where an accessible route crosses a barrier:	YES
	Is the slope of the ramp 1:12 or less:	NO
	Transition from curb ramp slope to roadway free from abrupt changes, no greater than 1:20:	YES
	Ramp is at least 36" wide:	YES
	Ramp surface is stable, firm, and slip resistant:	YES
<b>Flare</b>	Flares (if present) are 1:10 or less measured along the curb line; or If landing at top of ramp is not provided flares are 1:12 or less:	N/A
<b>Detectable Warning Surface</b>	Curb ramp is located such that it does not project into roadway or parking aisles:	N/A
	Detectable warning is present:	YES
	DWS maintains correct geometric controls; 0.9" diameter domes, 0.2" in height, spaced at 2.35" and visually contracts adjacent ramp surface:	NO
<b>Special Ramps</b>	Ramp maintains defined edges parallel to direction of pedestrian travel; maintains 4'x4' turning pad contained in crosswalk; flared sides 24" segment on each side of ramp within crosswalk lines:	YES

Ramp is located so they will not be obstructed by parked vehicles:	N/A
	Ramp wholly contained within the crosswalk lines:	YES
	If island is present; Island maintains a cut through at street level or ramps on either side with landing between them:	N/A
