**CITY OF SAN MARCOS
ADA TRANSITION PLAN
SIGNALIZED INTERSECTION ASSESSMENT
AND COMPLIANCE REPORT**

Location ID: 0000000106
 North-South Cross Street: HUNTER RD
 East-West Cross Street: FOXTAIL RUN

Date of Evaluation: 6/25/2014
 Latitude: 29.857451 Longitude: -97.969789
<https://maps.google.com/maps?t=h&q=29.857451+-97.969789>

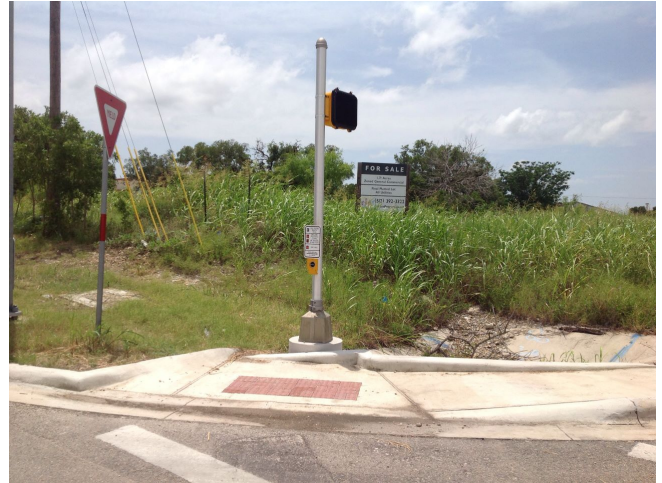
Signalized Intersection: YES
 Accessible Features: YES
 Pedestrian Features Accessible: YES

Ramp Elements	Curb ramp provided where an accessible route crosses a barrier:	YES
	Is the slope of the ramp 1:12 or less:	YES
	Transition from curb ramp slope to roadway free from abrupt changes, no greater than 1:20:	YES
	Ramp is at least 36" wide:	YES
	Ramp surface is stable, firm, and slip resistant:	YES
Flare	Flares (if present) are 1:10 or less measured along the curb line; or If landing at top of ramp is not provided flares are 1:12 or less:	N/A
Detectable Warning Surface	Curb ramp is located such that it does not project into roadway or parking aisles:	N/A
	Detectable warning is present:	YES
	DWS maintains correct geometric controls; 0.9" diameter domes, 0.2" in height, spaced at 2.35" and visually contracts adjacent ramp surface:	YES
Special Ramps	Ramp maintains defined edges parallel to direction of pedestrian travel; maintains 4'x4' turning pad contained in crosswalk; flared sides 24" segment on each side of ramp within crosswalk lines:	YES

Ramp is located so they will not be obstructed by parked vehicles:	N/A
	Ramp wholly contained within the crosswalk lines:	YES
	If island is present; Island maintains a cut through at street level or ramps on either side with landing between them:	N/A
