**CITY OF SAN MARCOS
ADA TRANSITION PLAN
SIGNALIZED INTERSECTION ASSESSMENT
AND COMPLIANCE REPORT**

Location ID: 0000000116
 North-South Cross Street: HOPKINS ST
 East-West Cross Street: COMANCHE ST

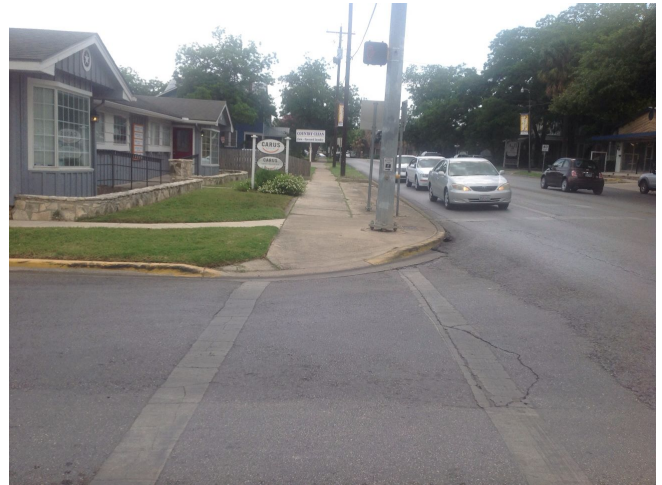
Ramp Elements	Curb ramp provided where an accessible route crosses a barrier:	YES
	Is the slope of the ramp 1:12 or less:	NO
	Transition from curb ramp slope to roadway free from abrupt changes, no greater than 1:20:	NO
	Ramp is at least 36" wide:	YES
	Ramp surface is stable, firm, and slip resistant:	YES
Flare	Flares (if present) are 1:10 or less measured along the curb line; or If landing at top of ramp is not provided flares are 1:12 or less:	NO
Detectable Warning Surface	Curb ramp is located such that it does not project into roadway or parking aisles:	N/A
	Detectable warning is present:	NO
	DWS maintains correct geometric controls; 0.9" diameter domes, 0.2" in height, spaced at 2.35" and visually contrasts adjacent ramp surface:	NO
Special Ramps	Ramp maintains defined edges parallel to direction of pedestrian travel; maintains 4'x4' turning pad contained in crosswalk; flared sides 24" segment on each side of ramp within crosswalk lines:	N/A

Ramp is located so they will not be obstructed by parked vehicles:	N/A
	Ramp wholly contained within the crosswalk lines:	YES
	If island is present; Island maintains a cut through at street level or ramps on either side with landing between them:	N/A
