**CITY OF SAN MARCOS
ADA TRANSITION PLAN
SIGNALIZED INTERSECTION ASSESSMENT
AND COMPLIANCE REPORT**

Location ID: 000000119
 North-South Cross Street: HOPKINS ST
 East-West Cross Street: MOORE ST

North-South Cross Street: HOPKINS ST

East-West Cross Street: MOORE ST

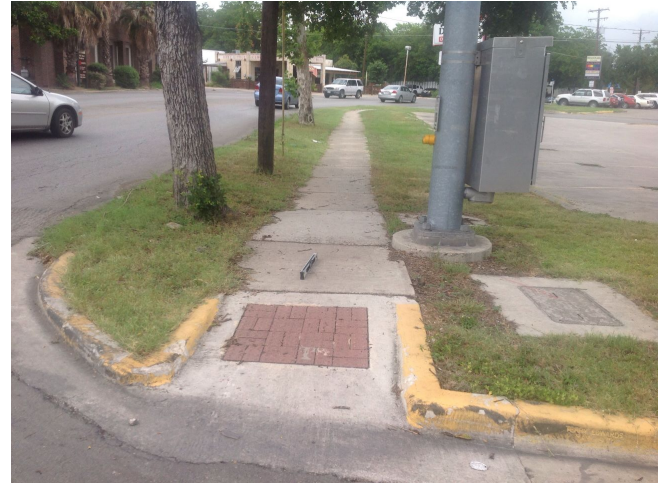
Signalized Intersection: YES
 Accessible Features: YES
 Pedestrian Features Accessible: YES

Ramp Elements	Curb ramp provided where an accessible route crosses a barrier:	YES
	Is the slope of the ramp 1:12 or less:	YES
	Transition from curb ramp slope to roadway free from abrupt changes, no greater than 1:20:	YES
	Ramp is at least 36" wide:	YES
	Ramp surface is stable, firm, and slip resistant:	YES
Flare	Flares (if present) are 1:10 or less measured along the curb line; or If landing at top of ramp is not provided flares are 1:12 or less:	N/A
Detectable Warning Surface	Curb ramp is located such that it does not project into roadway or parking aisles:	N/A
	Detectable warning is present:	NO
	DWS maintains correct geometric controls; 0.9" diameter domes, 0.2" in height, spaced at 2.35" and visually contrasts adjacent ramp surface:	YES
Special Ramps	Ramp maintains defined edges parallel to direction of pedestrian travel; maintains 4'x4' turning pad contained in crosswalk; flared sides 24" segment on each side of ramp within crosswalk lines:	N/A

Ramp is located so they will not be obstructed by parked vehicles:	N/A
	Ramp wholly contained within the crosswalk lines:	N/A
	If island is present; Island maintains a cut through at street level or ramps on either side with landing between them:	N/A
