CITY OF SAN MARCOS ADA TRANSITION PLAN SIGNALIZED INTERSECTION ASSESSMENT AND COMPLIANCE REPORT

Location ID: 0000000123
 North-South Cross Street: HUTCHISON ST
 East-West Cross Street: LBJ ST

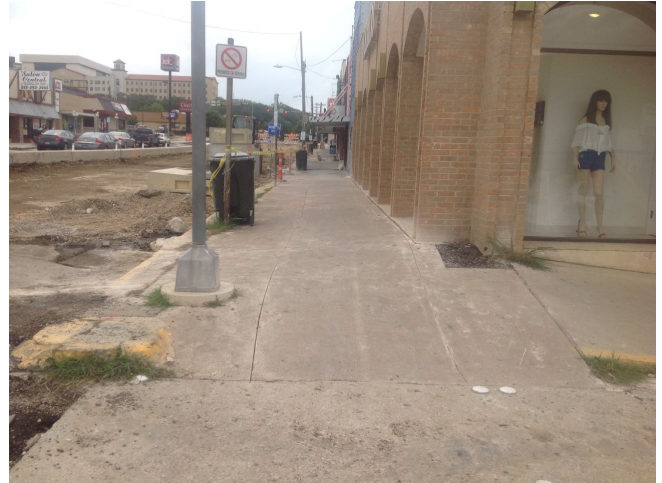
Signalized Intersection: YES
 Accessible Features: NO
 Pedestrian Features Accessible: NO

Ramp Elements	Curb ramp provided where an accessible route crosses a barrier:	YES
	Is the slope of the ramp 1:12 or less:	NO
	Transition from curb ramp slope to roadway free from abrupt changes, no greater than 1:20:	NO
	Ramp is at least 36" wide:	NO
	Ramp surface is stable, firm, and slip resistant:	YES
Flare	Flares (if present) are 1:10 or less measured along the curb line; or If landing at top of ramp is not provided flares are 1:12 or less:	YES
Detectable Warning Surface	Curb ramp is located such that it does not project into roadway or parking aisles:	YES
	Detectable warning is present:	NO
	DWS maintains correct geometric controls; 0.9" diameter domes, 0.2" in height, spaced at 2.35" and visually contracts adjacent ramp surface:	NO
Special Ramps	Ramp maintains defined edges parallel to direction of pedestrian travel; maintains 4'x4' turning pad contained in crosswalk; flared sides 24" segment on each side of ramp within crosswalk lines:	N/A

Ramp is located so they will not be obstructed by parked vehicles:	N/A
	Ramp wholly contained within the crosswalk lines:	N/A
	If island is present; Island maintains a cut through at street level or ramps on either side with landing between them:	N/A
