**CITY OF SAN MARCOS
ADA TRANSITION PLAN
SIGNALIZED INTERSECTION ASSESSMENT
AND COMPLIANCE REPORT**

Location ID: 0000000143
 North-South Cross Street: HUTCHISON ST
 East-West Cross Street: GUADALUPE ST

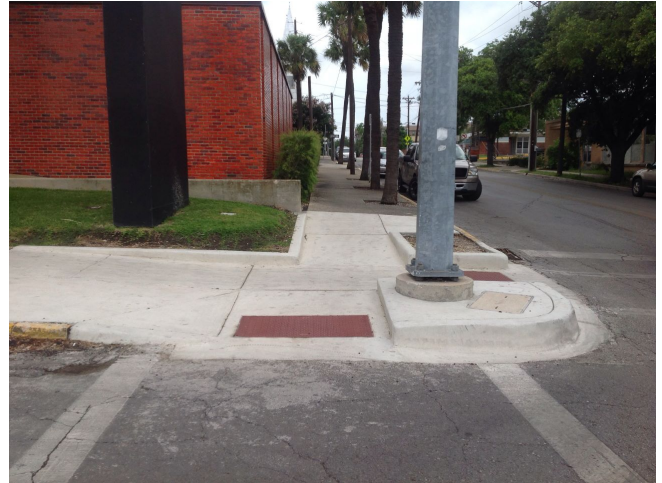
Signalized Intersection: YES
 Accessible Features: NO
 Pedestrian Features Accessible: NO

Ramp Elements	Curb ramp provided where an accessible route crosses a barrier:	YES
	Is the slope of the ramp 1:12 or less:	YES
	Transition from curb ramp slope to roadway free from abrupt changes, no greater than 1:20:	YES
	Ramp is at least 36" wide:	YES
	Ramp surface is stable, firm, and slip resistant:	YES
Flare	Flares (if present) are 1:10 or less measured along the curb line; or If landing at top of ramp is not provided flares are 1:12 or less:	YES
Detectable Warning Surface	Curb ramp is located such that it does not project into roadway or parking aisles:	N/A
	Detectable warning is present:	NO
	DWS maintains correct geometric controls; 0.9" diameter domes, 0.2" in height, spaced at 2.35" and visually contrasts adjacent ramp surface:	YES
Special Ramps	Ramp maintains defined edges parallel to direction of pedestrian travel; maintains 4'x4' turning pad contained in crosswalk; flared sides 24" segment on each side of ramp within crosswalk lines:	N/A

Ramp is located so they will not be obstructed by parked vehicles:	N/A
	Ramp wholly contained within the crosswalk lines:	YES
	If island is present; Island maintains a cut through at street level or ramps on either side with landing between them:	N/A
