**CITY OF SAN MARCOS  
ADA TRANSITION PLAN  
SIGNALIZED INTERSECTION ASSESSMENT  
AND COMPLIANCE REPORT**

Location ID: 0000000162  
 North-South Cross Street: THORPE LN  
 East-West Cross Street: ROBBIE LN

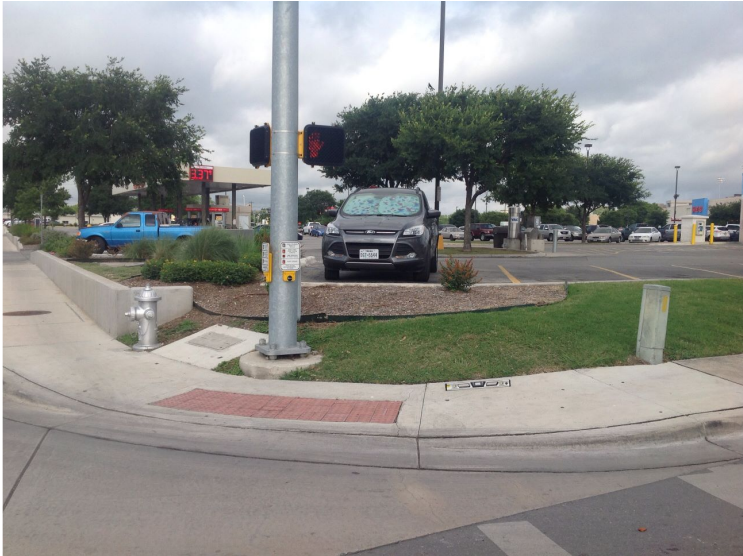
**Location Photos**

| | Transition from curb ramp slope to roadway free from abrupt changes, no greater than 1:20: | NO |
