**CITY OF SAN MARCOS  
ADA TRANSITION PLAN  
SIGNALIZED INTERSECTION ASSESSMENT  
AND COMPLIANCE REPORT**

Location ID: 0000000171  
 North-South Cross Street: IH 35 SBFR  
 East-West Cross Street: AQUARENA SPRINGS DR

Location ID: 0000000171

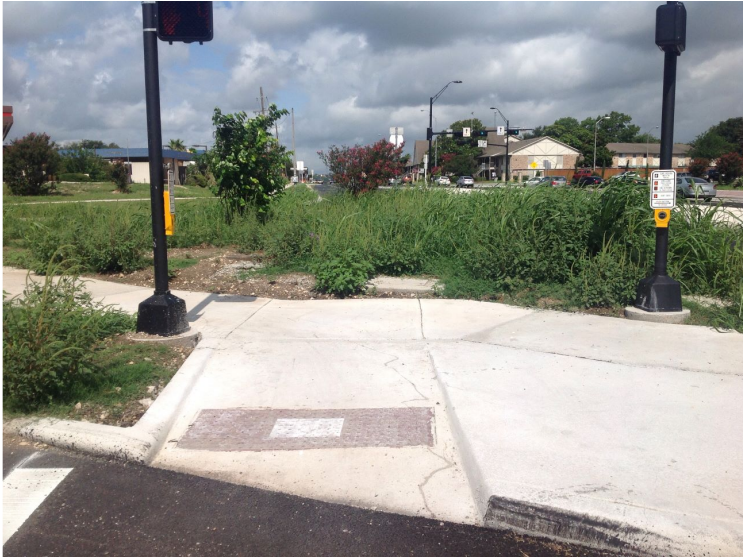
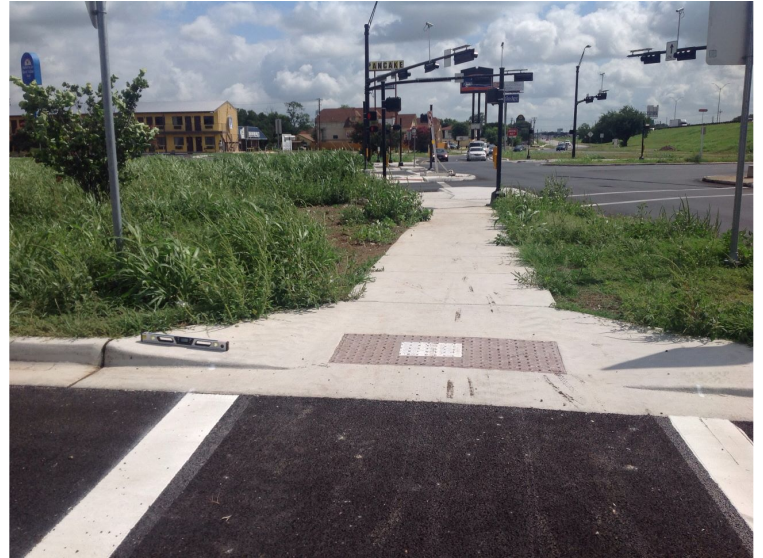
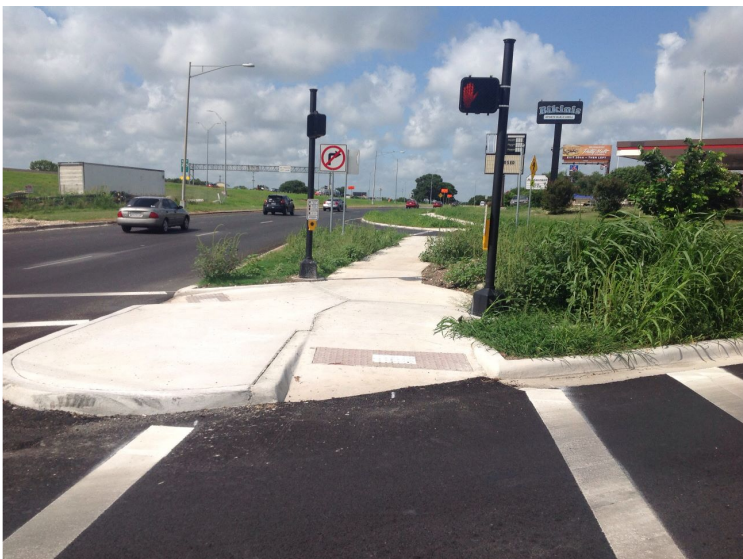
## Location Photos

<b>Ramp Elements</b>	Curb ramp provided where an accessible route crosses a barrier:	YES
	Is the slope of the ramp 1:12 or less:	YES
	Transition from curb ramp slope to roadway free from abrupt changes, no greater than 1:20:	YES
	Ramp is at least 36" wide:	YES
	Ramp surface is stable, firm, and slip resistant:	YES
<b>Flare</b>	Flares (if present) are 1:10 or less measured along the curb line; or If landing at top of ramp is not provided flares are 1:12 or less:	NO
<b>Detectable Warning Surface</b>	Curb ramp is located such that it does not project into roadway or parking aisles:	N/A
	Detectable warning is present:	YES
	DWS maintains correct geometric controls; 0.9" diameter domes, 0.2" in height, spaced at 2.35" and visually contracts adjacent ramp surface:	YES
<b>Special Ramps</b>	Ramp maintains defined edges parallel to direction of pedestrian travel; maintains 4'x4' turning pad contained in crosswalk; flared sides 24" segment on each side of ramp within crosswalk lines:	N/A

Ramp is located so they will not be obstructed by parked vehicles:	N/A
	Ramp wholly contained within the crosswalk lines:	YES
	If island is present; Island maintains a cut through at street level or ramps on either side with landing between them:	YES
