CITY OF SAN MARCOS ADA TRANSITION PLAN SIGNALIZED INTERSECTION ASSESSMENT AND COMPLIANCE REPORT

Location ID: 0000000178
 North-South Cross Street: IH 35 SBFR
 East-West Cross Street: AQUARENA SPRINGS DR

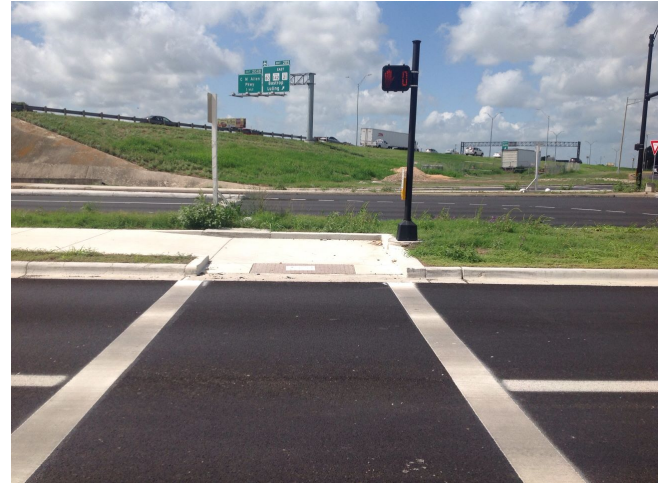
Signalized Intersection: YES
 Accessible Features: YES
 Pedestrian Features Accessible: YES

Ramp Elements	Curb ramp provided where an accessible route crosses a barrier:	YES
	Is the slope of the ramp 1:12 or less:	YES
	Transition from curb ramp slope to roadway free from abrupt changes, no greater than 1:20:	YES
	Ramp is at least 36" wide:	YES
	Ramp surface is stable, firm, and slip resistant:	YES
Flare	Flares (if present) are 1:10 or less measured along the curb line; or If landing at top of ramp is not provided flares are 1:12 or less:	N/A
Detectable Warning Surface	Curb ramp is located such that it does not project into roadway or parking aisles:	N/A
	Detectable warning is present:	NO
	DWS maintains correct geometric controls; 0.9" diameter domes, 0.2" in height, spaced at 2.35" and visually contracts adjacent ramp surface:	YES
Special Ramps	Ramp maintains defined edges parallel to direction of pedestrian travel; maintains 4'x4' turning pad contained in crosswalk; flared sides 24" segment on each side of ramp within crosswalk lines:	N/A

Ramp is located so they will not be obstructed by parked vehicles:	N/A
	Ramp wholly contained within the crosswalk lines:	YES
	If island is present; Island maintains a cut through at street level or ramps on either side with landing between them:	YES
