**CITY OF SAN MARCOS  
ADA TRANSITION PLAN  
SIGNALIZED INTERSECTION ASSESSMENT  
AND COMPLIANCE REPORT**

Location ID: 0000000183  
 North-South Cross Street: IH 35 NBFR  
 East-West Cross Street: TX HWY 80

Location ID: 0000000183

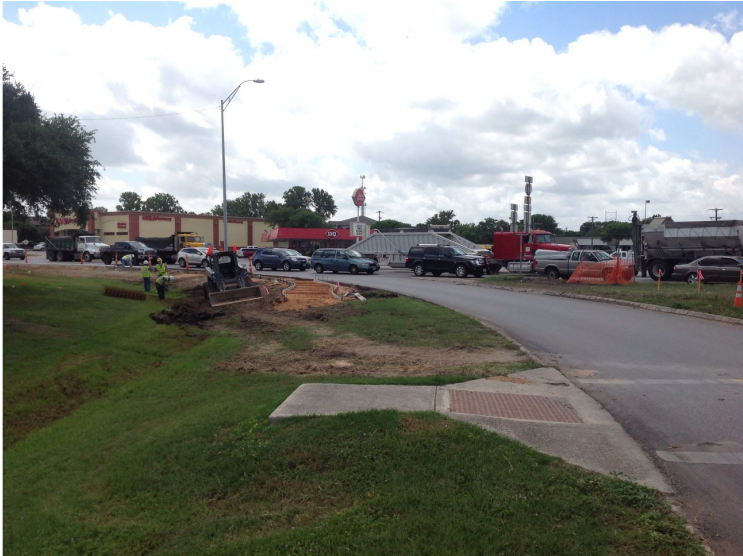
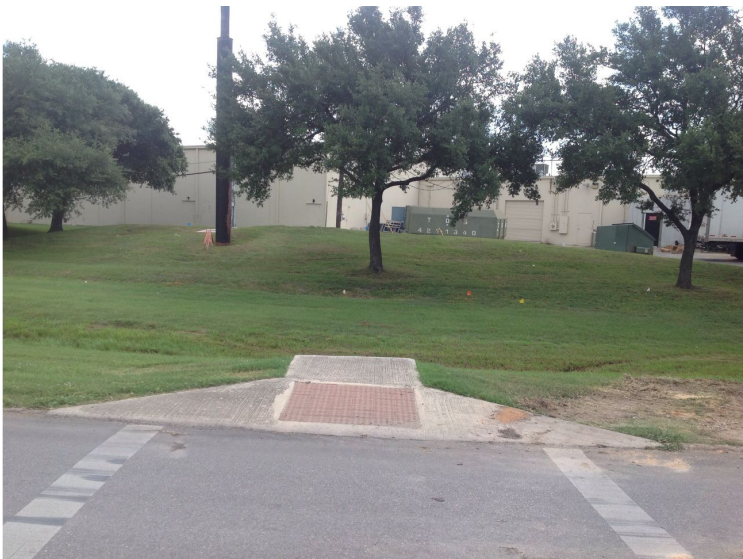
## Location Photos

Signalized Intersection: YES  
 Accessible Features: NO  
 Pedestrian Features Accessible: NO

<b>Ramp Elements</b>	Curb ramp provided where an accessible route crosses a barrier:	YES
	Is the slope of the ramp 1:12 or less:	YES
	Transition from curb ramp slope to roadway free from abrupt changes, no greater than 1:20:	YES
	Ramp is at least 36" wide:	YES
	Ramp surface is stable, firm, and slip resistant:	YES
<b>Flare</b>	Flares (if present) are 1:10 or less measured along the curb line; or If landing at top of ramp is not provided flares are 1:12 or less:	YES
<b>Detectable Warning Surface</b>	Curb ramp is located such that it does not project into roadway or parking aisles:	N/A
	Detectable warning is present:	YES
	DWS maintains correct geometric controls; 0.9" diameter domes, 0.2" in height, spaced at 2.35" and visually contracts adjacent ramp surface:	YES
<b>Special Ramps</b>	Ramp maintains defined edges parallel to direction of pedestrian travel; maintains 4'x4' turning pad contained in crosswalk; flared sides 24" segment on each side of ramp within crosswalk lines:	N/A

Ramp is located so they will not be obstructed by parked vehicles:	N/A
	Ramp wholly contained within the crosswalk lines:	YES
	If island is present; Island maintains a cut through at street level or ramps on either side with landing between them:	YES
