# CITY OF SAN MARCOS ADA TRANSITION PLAN SIGNALIZED INTERSECTION ASSESSMENT AND COMPLIANCE REPORT

Location ID: 0000000186  
 North-South Cross Street: IH 35 NBFR  
 East-West Cross Street: TX HWY 80

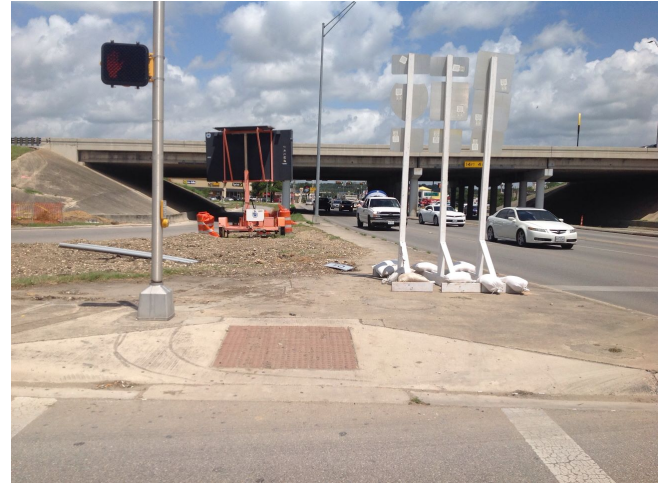
Signalized Intersection: YES  
 Accessible Features: YES  
 Pedestrian Features Accessible: YES

<b>Ramp Elements</b>	Curb ramp provided where an accessible route crosses a barrier:	YES
	Is the slope of the ramp 1:12 or less:	YES
	Transition from curb ramp slope to roadway free from abrupt changes, no greater than 1:20:	YES
	Ramp is at least 36" wide:	YES
	Ramp surface is stable, firm, and slip resistant:	YES
<b>Flare</b>	Flares (if present) are 1:10 or less measured along the curb line; or If landing at top of ramp is not provided flares are 1:12 or less:	YES
<b>Detectable Warning Surface</b>	Curb ramp is located such that it does not project into roadway or parking aisles:	N/A
	Detectable warning is present:	YES
	DWS maintains correct geometric controls; 0.9" diameter domes, 0.2" in height, spaced at 2.35" and visually contrasts adjacent ramp surface:	YES
<b>Special Ramps</b>	Ramp maintains defined edges parallel to direction of pedestrian travel; maintains 4'x4' turning pad contained in crosswalk; flared sides 24" segment on each side of ramp within crosswalk lines:	YES

Ramp is located so they will not be obstructed by parked vehicles:	N/A
	Ramp wholly contained within the crosswalk lines:	YES
	If island is present; Island maintains a cut through at street level or ramps on either side with landing between them:	N/A
