# CITY OF SAN MARCOS ADA TRANSITION PLAN SIGNALIZED INTERSECTION ASSESSMENT AND COMPLIANCE REPORT

Location ID: 0000000193  
 North-South Cross Street: RIVER RD  
 East-West Cross Street: TX HWY 80

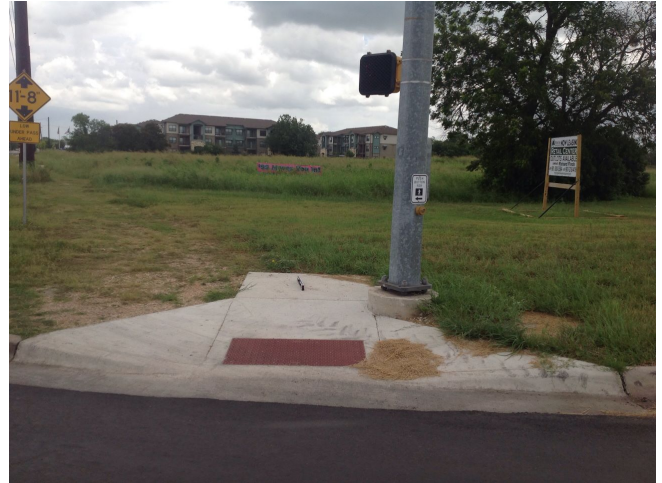
Signalized Intersection: YES  
 Accessible Features: YES  
 Pedestrian Features Accessible: NO

<b>Ramp Elements</b>	Curb ramp provided where an accessible route crosses a barrier:	YES
	Is the slope of the ramp 1:12 or less:	YES
	Transition from curb ramp slope to roadway free from abrupt changes, no greater than 1:20:	YES
	Ramp is at least 36" wide:	YES
	Ramp surface is stable, firm, and slip resistant:	YES
<b>Flare</b>	Flares (if present) are 1:10 or less measured along the curb line; or If landing at top of ramp is not provided flares are 1:12 or less:	YES
<b>Detectable Warning Surface</b>	Curb ramp is located such that it does not project into roadway or parking aisles:	N/A
	Detectable warning is present:	YES
	DWS maintains correct geometric controls; 0.9" diameter domes, 0.2" in height, spaced at 2.35" and visually contracts adjacent ramp surface:	YES
<b>Special Ramps</b>	Ramp maintains defined edges parallel to direction of pedestrian travel; maintains 4'x4' turning pad contained in crosswalk; flared sides 24" segment on each side of ramp within crosswalk lines:	N/A

Ramp is located so they will not be obstructed by parked vehicles:	N/A
	Ramp wholly contained within the crosswalk lines:	N/A
	If island is present; Island maintains a cut through at street level or ramps on either side with landing between them:	N/A
