CITY OF SAN MARCOS ADA TRANSITION PLAN SIGNALIZED INTERSECTION ASSESSMENT AND COMPLIANCE REPORT

Location ID: 0000000195
 North-South Cross Street: IH 35 SBFR
 East-West Cross Street: CENTERPOINT RD

Date of Evaluation: 6/25/2014

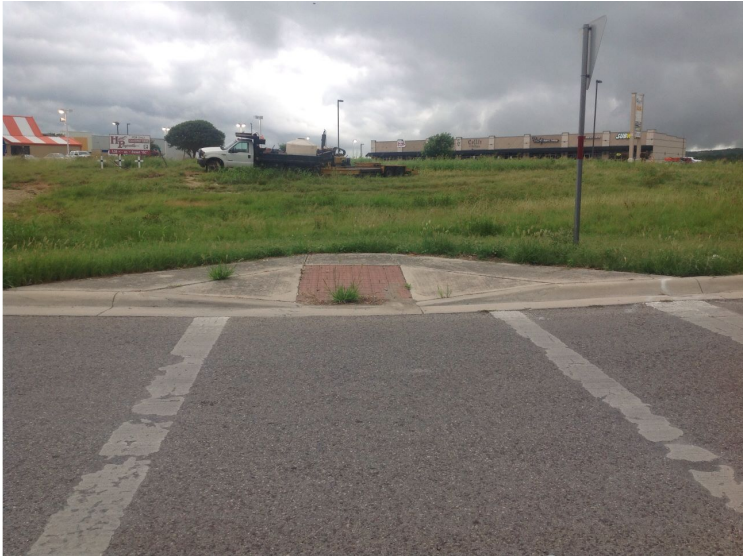
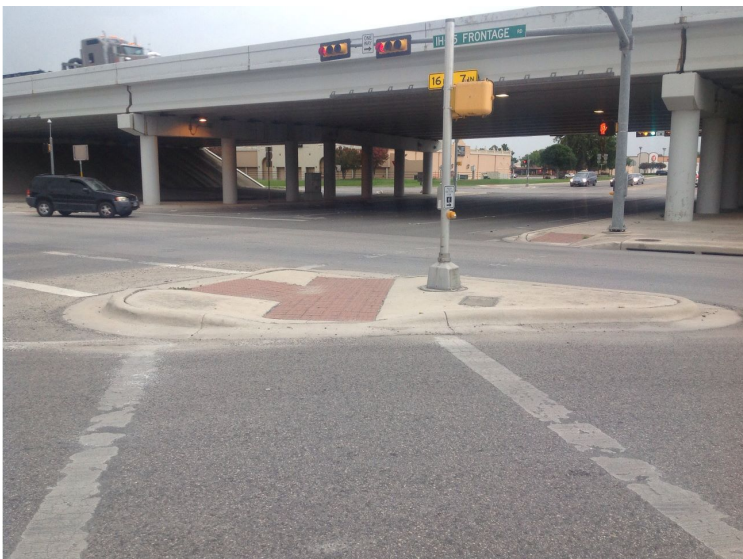
Location Photos

Ramp Elements	Curb ramp provided where an accessible route crosses a barrier:	YES
	Is the slope of the ramp 1:12 or less:	YES
	Transition from curb ramp slope to roadway free from abrupt changes, no greater than 1:20:	YES
	Ramp is at least 36" wide:	YES
	Ramp surface is stable, firm, and slip resistant:	YES
Flare	Flares (if present) are 1:10 or less measured along the curb line; or If landing at top of ramp is not provided flares are 1:12 or less:	NO
Detectable Warning Surface	Curb ramp is located such that it does not project into roadway or parking aisles:	N/A
	Detectable warning is present:	YES
	DWS maintains correct geometric controls; 0.9" diameter domes, 0.2" in height, spaced at 2.35" and visually contracts adjacent ramp surface:	YES
Special Ramps	Ramp maintains defined edges parallel to direction of pedestrian travel; maintains 4'x4' turning pad contained in crosswalk; flared sides 24" segment on each side of ramp within crosswalk lines:	YES

Ramp is located so they will not be obstructed by parked vehicles:	N/A
	Ramp wholly contained within the crosswalk lines:	YES
	If island is present; Island maintains a cut through at street level or ramps on either side with landing between them:	YES
