**CITY OF SAN MARCOS
ADA TRANSITION PLAN
SIGNALIZED INTERSECTION ASSESSMENT
AND COMPLIANCE REPORT**

Location ID: 0000000200
 North-South Cross Street: MCCARTY LN
 East-West Cross Street: MCCARTY LN

Location ID: 0000000200

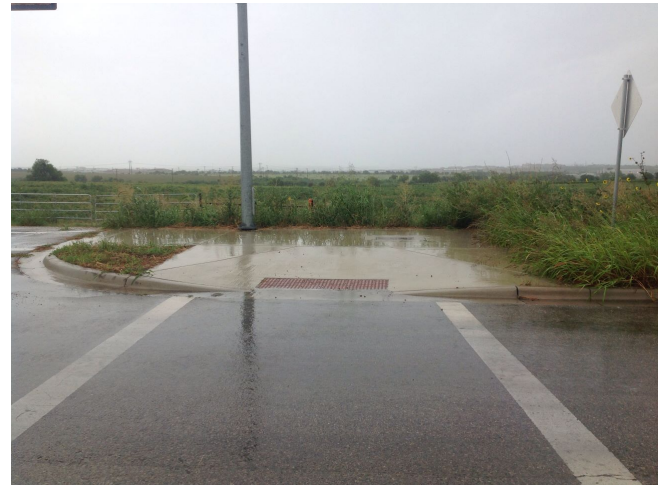
Signalized Intersection: YES
 Accessible Features: NO
 Pedestrian Features Accessible: NO

Ramp Elements	Curb ramp provided where an accessible route crosses a barrier:	YES
	Is the slope of the ramp 1:12 or less:	NO
	Transition from curb ramp slope to roadway free from abrupt changes, no greater than 1:20:	YES
	Ramp is at least 36" wide:	YES
	Ramp surface is stable, firm, and slip resistant:	YES
Flare	Flares (if present) are 1:10 or less measured along the curb line; or If landing at top of ramp is not provided flares are 1:12 or less:	YES
Detectable Warning Surface	Curb ramp is located such that it does not project into roadway or parking aisles:	N/A
	Detectable warning is present:	YES
	DWS maintains correct geometric controls; 0.9" diameter domes, 0.2" in height, spaced at 2.35" and visually contracts adjacent ramp surface:	YES
Special Ramps	Ramp maintains defined edges parallel to direction of pedestrian travel; maintains 4'x4' turning pad contained in crosswalk; flared sides 24" segment on each side of ramp within crosswalk lines:	N/A

Ramp is located so they will not be obstructed by parked vehicles:	N/A
	Ramp wholly contained within the crosswalk lines:	YES
	If island is present; Island maintains a cut through at street level or ramps on either side with landing between them:	N/A
