**CITY OF SAN MARCOS
ADA TRANSITION PLAN
SIGNALIZED INTERSECTION ASSESSMENT
AND COMPLIANCE REPORT**

Location ID: 000000203
 North-South Cross Street: SADLER DR
 East-West Cross Street: WONDER WORLD DR

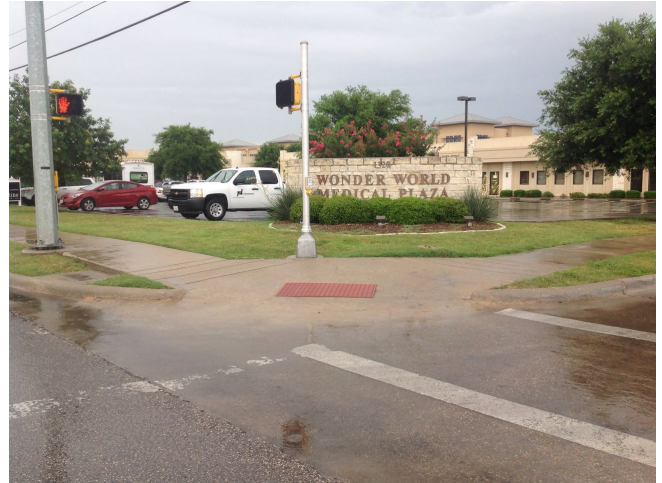
Signalized Intersection: YES
 Accessible Features: YES
 Pedestrian Features Accessible: YES

Ramp Elements	Curb ramp provided where an accessible route crosses a barrier:	YES
	Is the slope of the ramp 1:12 or less:	YES
	Transition from curb ramp slope to roadway free from abrupt changes, no greater than 1:20:	YES
	Ramp is at least 36" wide:	YES
	Ramp surface is stable, firm, and slip resistant:	YES
Flare	Flares (if present) are 1:10 or less measured along the curb line; or If landing at top of ramp is not provided flares are 1:12 or less:	NO
Detectable Warning Surface	Curb ramp is located such that it does not project into roadway or parking aisles:	N/A
	Detectable warning is present:	NO
	DWS maintains correct geometric controls; 0.9" diameter domes, 0.2" in height, spaced at 2.35" and visually contracts adjacent ramp surface:	YES
Special Ramps	Ramp maintains defined edges parallel to direction of pedestrian travel; maintains 4'x4' turning pad contained in crosswalk; flared sides 24" segment on each side of ramp within crosswalk lines:	YES

Ramp is located so they will not be obstructed by parked vehicles:	N/A
	Ramp wholly contained within the crosswalk lines:	YES
	If island is present; Island maintains a cut through at street level or ramps on either side with landing between them:	N/A
