**CITY OF SAN MARCOS
ADA TRANSITION PLAN
SIGNALIZED INTERSECTION ASSESSMENT
AND COMPLIANCE REPORT**

Location ID: 000000205
 North-South Cross Street: SH 123
 East-West Cross Street: DE ZAVALA DR

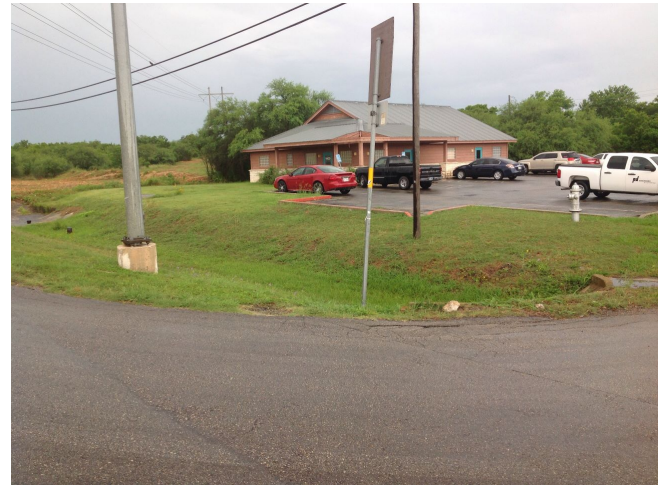
Signalized Intersection: YES
 Accessible Features: NO
 Pedestrian Features Accessible: NO

Ramp Elements	Curb ramp provided where an accessible route crosses a barrier:	NO
	Is the slope of the ramp 1:12 or less:	NO
	Transition from curb ramp slope to roadway free from abrupt changes, no greater than 1:20:	NO
	Ramp is at least 36" wide:	NO
	Ramp surface is stable, firm, and slip resistant:	NO
Flare	Flares (if present) are 1:10 or less measured along the curb line; or If landing at top of ramp is not provided flares are 1:12 or less:	NO
Detectable Warning Surface	Curb ramp is located such that it does not project into roadway or parking aisles:	N/A
	Detectable warning is present:	NO
	DWS maintains correct geometric controls; 0.9" diameter domes, 0.2" in height, spaced at 2.35" and visually contracts adjacent ramp surface:	NO
Special Ramps	Ramp maintains defined edges parallel to direction of pedestrian travel; maintains 4'x4' turning pad contained in crosswalk; flared sides 24" segment on each side of ramp within crosswalk lines:	N/A

Ramp is located so they will not be obstructed by parked vehicles:	N/A
	Ramp wholly contained within the crosswalk lines:	N/A
	If island is present; Island maintains a cut through at street level or ramps on either side with landing between them:	N/A
