CITY OF SAN MARCOS ADA TRANSITION PLAN SIGNALIZED INTERSECTION ASSESSMENT AND COMPLIANCE REPORT

Location ID: 000000208
 North-South Cross Street: SH 123
 East-West Cross Street: BROADWAY ST

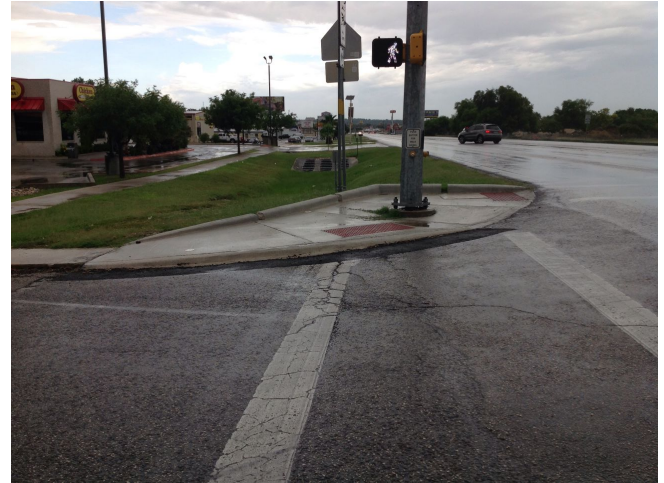
Signalized Intersection: YES
 Accessible Features: YES
 Pedestrian Features Accessible: YES

Ramp Elements	Curb ramp provided where an accessible route crosses a barrier:	YES
	Is the slope of the ramp 1:12 or less:	YES
	Transition from curb ramp slope to roadway free from abrupt changes, no greater than 1:20:	NO
	Ramp is at least 36" wide:	YES
	Ramp surface is stable, firm, and slip resistant:	YES
Flare	Flares (if present) are 1:10 or less measured along the curb line; or If landing at top of ramp is not provided flares are 1:12 or less:	NO
Detectable Warning Surface	Curb ramp is located such that it does not project into roadway or parking aisles:	N/A
	Detectable warning is present:	YES
	DWS maintains correct geometric controls; 0.9" diameter domes, 0.2" in height, spaced at 2.35" and visually contracts adjacent ramp surface:	YES
Special Ramps	Ramp maintains defined edges parallel to direction of pedestrian travel; maintains 4'x4' turning pad contained in crosswalk; flared sides 24" segment on each side of ramp within crosswalk lines:	N/A

Ramp is located so they will not be obstructed by parked vehicles:	N/A
	Ramp wholly contained within the crosswalk lines:	YES
	If island is present; Island maintains a cut through at street level or ramps on either side with landing between them:	N/A
