**CITY OF SAN MARCOS
ADA TRANSITION PLAN
SIGNALIZED INTERSECTION ASSESSMENT
AND COMPLIANCE REPORT**

Location ID: 000000224
 North-South Cross Street: HOPKINS ST
 East-West Cross Street: BISHOP ST

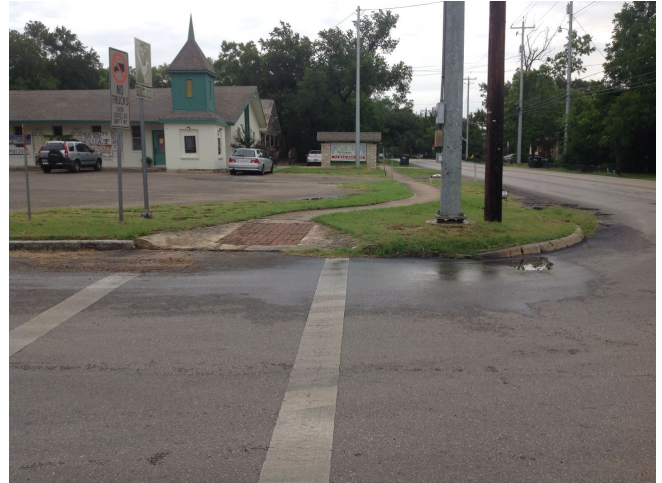
Signalized Intersection: YES
 Accessible Features: NO
 Pedestrian Features Accessible: NO

Ramp Elements	Curb ramp provided where an accessible route crosses a barrier:	YES
	Is the slope of the ramp 1:12 or less:	YES
	Transition from curb ramp slope to roadway free from abrupt changes, no greater than 1:20:	NO
	Ramp is at least 36" wide:	YES
	Ramp surface is stable, firm, and slip resistant:	YES
Flare	Flares (if present) are 1:10 or less measured along the curb line; or If landing at top of ramp is not provided flares are 1:12 or less:	YES
Detectable Warning Surface	Curb ramp is located such that it does not project into roadway or parking aisles:	N/A
	Detectable warning is present:	YES
	DWS maintains correct geometric controls; 0.9" diameter domes, 0.2" in height, spaced at 2.35" and visually contracts adjacent ramp surface:	YES
Special Ramps	Ramp maintains defined edges parallel to direction of pedestrian travel; maintains 4'x4' turning pad contained in crosswalk; flared sides 24" segment on each side of ramp within crosswalk lines:	N/A

Ramp is located so they will not be obstructed by parked vehicles:	N/A
	Ramp wholly contained within the crosswalk lines:	YES
	If island is present; Island maintains a cut through at street level or ramps on either side with landing between them:	N/A
