**CITY OF SAN MARCOS  
ADA TRANSITION PLAN  
SIGNALIZED INTERSECTION ASSESSMENT  
AND COMPLIANCE REPORT**

Location ID: 0000000246  
 North-South Cross Street: HOPKINS RD  
 East-West Cross Street: COMMANCHE ST

North-South Cross Street: HOPKINS RD

East-West Cross Street: COMMANCHE ST

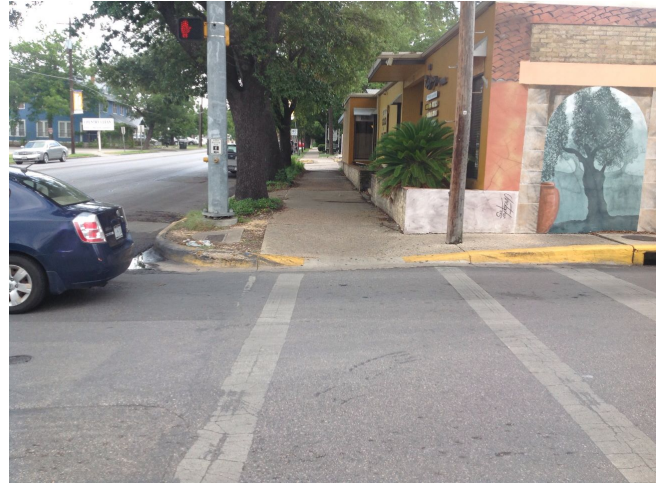
Signalized Intersection: YES  
 Accessible Features: YES  
 Pedestrian Features Accessible: NO

<b>Ramp Elements</b>	Curb ramp provided where an accessible route crosses a barrier:	YES
	Is the slope of the ramp 1:12 or less:	NO
	Transition from curb ramp slope to roadway free from abrupt changes, no greater than 1:20:	NO
	Ramp is at least 36" wide:	YES
	Ramp surface is stable, firm, and slip resistant:	YES
<b>Flare</b>	Flares (if present) are 1:10 or less measured along the curb line; or If landing at top of ramp is not provided flares are 1:12 or less:	YES
<b>Detectable Warning Surface</b>	Curb ramp is located such that it does not project into roadway or parking aisles:	N/A
	Detectable warning is present:	NO
	DWS maintains correct geometric controls; 0.9" diameter domes, 0.2" in height, spaced at 2.35" and visually contracts adjacent ramp surface:	NO
<b>Special Ramps</b>	Ramp maintains defined edges parallel to direction of pedestrian travel; maintains 4'x4' turning pad contained in crosswalk; flared sides 24" segment on each side of ramp within crosswalk lines:	N/A

Ramp is located so they will not be obstructed by parked vehicles:	N/A
	Ramp wholly contained within the crosswalk lines:	YES
	If island is present; Island maintains a cut through at street level or ramps on either side with landing between them:	N/A
