CITY OF SAN MARCOS ADA TRANSITION PLAN SIGNALIZED INTERSECTION ASSESSMENT AND COMPLIANCE REPORT

Location ID: 0000000248
 North-South Cross Street: HOPKINS ST
 East-West Cross Street: MOORE ST

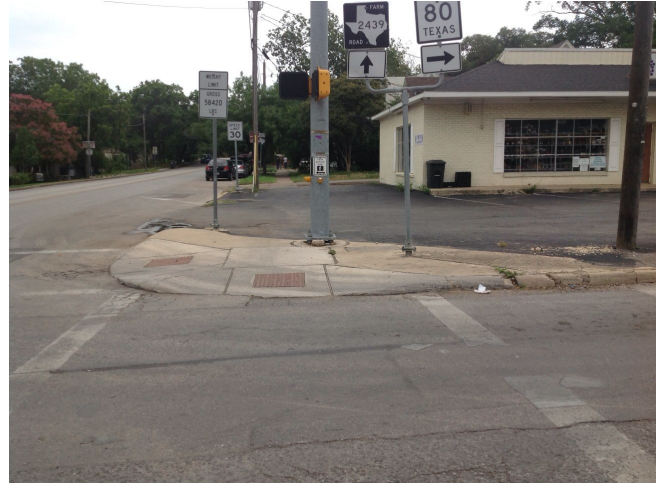
Signalized Intersection: YES
 Accessible Features: YES
 Pedestrian Features Accessible: YES

Ramp Elements	Curb ramp provided where an accessible route crosses a barrier:	YES
	Is the slope of the ramp 1:12 or less:	NO
	Transition from curb ramp slope to roadway free from abrupt changes, no greater than 1:20:	NO
	Ramp is at least 36" wide:	YES
	Ramp surface is stable, firm, and slip resistant:	YES
Flare	Flares (if present) are 1:10 or less measured along the curb line; or If landing at top of ramp is not provided flares are 1:12 or less:	YES
Detectable Warning Surface	Curb ramp is located such that it does not project into roadway or parking aisles:	N/A
	Detectable warning is present:	NO
	DWS maintains correct geometric controls; 0.9" diameter domes, 0.2" in height, spaced at 2.35" and visually contracts adjacent ramp surface:	YES
Special Ramps	Ramp maintains defined edges parallel to direction of pedestrian travel; maintains 4'x4' turning pad contained in crosswalk; flared sides 24" segment on each side of ramp within crosswalk lines:	N/A

Ramp is located so they will not be obstructed by parked vehicles:	N/A
	Ramp wholly contained within the crosswalk lines:	YES
	If island is present; Island maintains a cut through at street level or ramps on either side with landing between them:	N/A
