CITY OF SAN MARCOS ADA TRANSITION PLAN SIGNALIZED INTERSECTION ASSESSMENT AND COMPLIANCE REPORT

Location ID: 0000000251
 North-South Cross Street: HUTCHISON
 East-West Cross Street: LBJ

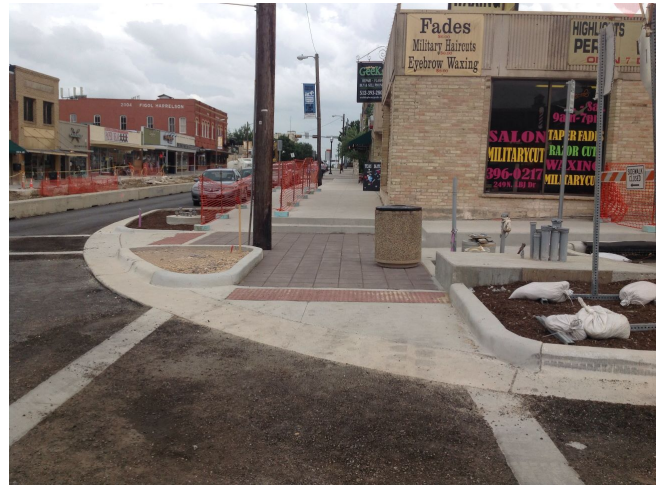
Signalized Intersection: YES
 Accessible Features: NO
 Pedestrian Features Accessible: NO

Ramp Elements	Curb ramp provided where an accessible route crosses a barrier:	YES
	Is the slope of the ramp 1:12 or less:	YES
	Transition from curb ramp slope to roadway free from abrupt changes, no greater than 1:20:	YES
	Ramp is at least 36" wide:	YES
	Ramp surface is stable, firm, and slip resistant:	YES
Flare	Flares (if present) are 1:10 or less measured along the curb line; or If landing at top of ramp is not provided flares are 1:12 or less:	NO
Detectable Warning Surface	Curb ramp is located such that it does not project into roadway or parking aisles:	N/A
	Detectable warning is present:	YES
	DWS maintains correct geometric controls; 0.9" diameter domes, 0.2" in height, spaced at 2.35" and visually contracts adjacent ramp surface:	NO
Special Ramps	Ramp maintains defined edges parallel to direction of pedestrian travel; maintains 4'x4' turning pad contained in crosswalk; flared sides 24" segment on each side of ramp within crosswalk lines:	N/A

Ramp is located so they will not be obstructed by parked vehicles:	N/A
	Ramp wholly contained within the crosswalk lines:	YES
	If island is present; Island maintains a cut through at street level or ramps on either side with landing between them:	N/A
