**CITY OF SAN MARCOS
ADA TRANSITION PLAN
SIGNALIZED INTERSECTION ASSESSMENT
AND COMPLIANCE REPORT**

Location ID: 0000000252
 North-South Cross Street: HUTCHISON
 East-West Cross Street: LBJ

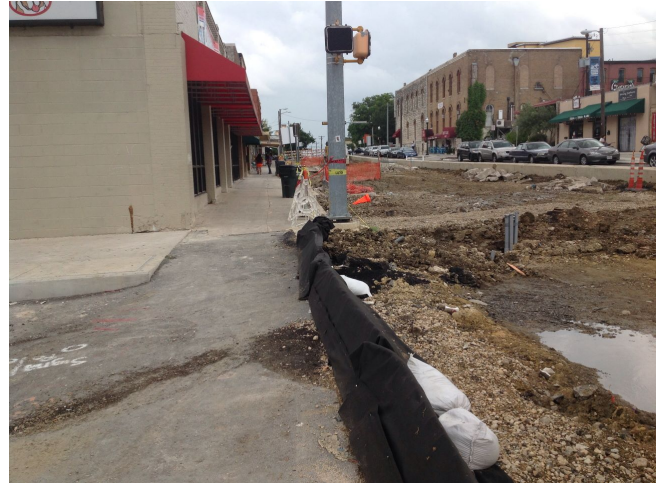
Signalized Intersection: YES
 Accessible Features: NO
 Pedestrian Features Accessible: NO

Ramp Elements	Curb ramp provided where an accessible route crosses a barrier:	YES
	Is the slope of the ramp 1:12 or less:	YES
	Transition from curb ramp slope to roadway free from abrupt changes, no greater than 1:20:	YES
	Ramp is at least 36" wide:	YES
	Ramp surface is stable, firm, and slip resistant:	YES
Flare	Flares (if present) are 1:10 or less measured along the curb line; or If landing at top of ramp is not provided flares are 1:12 or less:	N/A
Detectable Warning Surface	Curb ramp is located such that it does not project into roadway or parking aisles:	N/A
	Detectable warning is present:	YES
	DWS maintains correct geometric controls; 0.9" diameter domes, 0.2" in height, spaced at 2.35" and visually contracts adjacent ramp surface:	YES
Special Ramps	Ramp maintains defined edges parallel to direction of pedestrian travel; maintains 4'x4' turning pad contained in crosswalk; flared sides 24" segment on each side of ramp within crosswalk lines:	N/A

Ramp is located so they will not be obstructed by parked vehicles:	N/A
	Ramp wholly contained within the crosswalk lines:	YES
	If island is present; Island maintains a cut through at street level or ramps on either side with landing between them:	N/A
