**CITY OF SAN MARCOS
ADA TRANSITION PLAN
SIGNALIZED INTERSECTION ASSESSMENT
AND COMPLIANCE REPORT**

Location ID: 0000000256
 North-South Cross Street: GARRISON ST
 East-West Cross Street: GUADALUPE ST

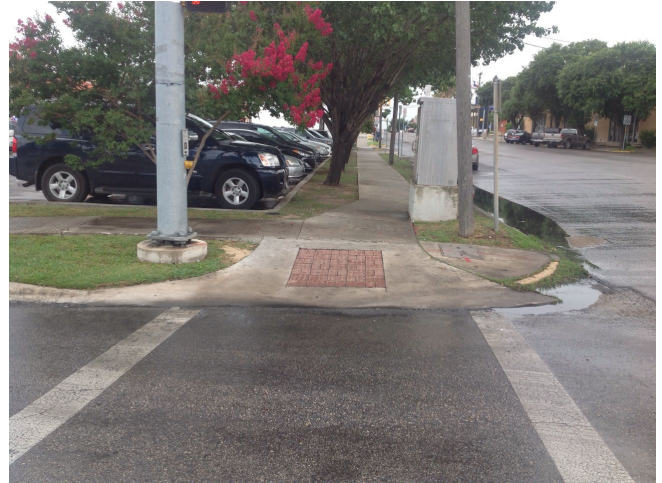
Signalized Intersection: YES
 Accessible Features: YES
 Pedestrian Features Accessible: NO

Ramp Elements	Curb ramp provided where an accessible route crosses a barrier:	YES
	Is the slope of the ramp 1:12 or less:	YES
	Transition from curb ramp slope to roadway free from abrupt changes, no greater than 1:20:	NO
	Ramp is at least 36" wide:	YES
	Ramp surface is stable, firm, and slip resistant:	YES
Flare	Flares (if present) are 1:10 or less measured along the curb line; or If landing at top of ramp is not provided flares are 1:12 or less:	YES
Detectable Warning Surface	Curb ramp is located such that it does not project into roadway or parking aisles:	N/A
	Detectable warning is present:	NO
	DWS maintains correct geometric controls; 0.9" diameter domes, 0.2" in height, spaced at 2.35" and visually contracts adjacent ramp surface:	YES
Special Ramps	Ramp maintains defined edges parallel to direction of pedestrian travel; maintains 4'x4' turning pad contained in crosswalk; flared sides 24" segment on each side of ramp within crosswalk lines:	N/A

Ramp is located so they will not be obstructed by parked vehicles:	N/A
	Ramp wholly contained within the crosswalk lines:	YES
	If island is present; Island maintains a cut through at street level or ramps on either side with landing between them:	N/A
