CITY OF SAN MARCOS ADA TRANSITION PLAN SIGNALIZED INTERSECTION ASSESSMENT AND COMPLIANCE REPORT

Location ID: 0000000257
 North-South Cross Street: UNIVERSITY DR
 East-West Cross Street: EDWARD GARY

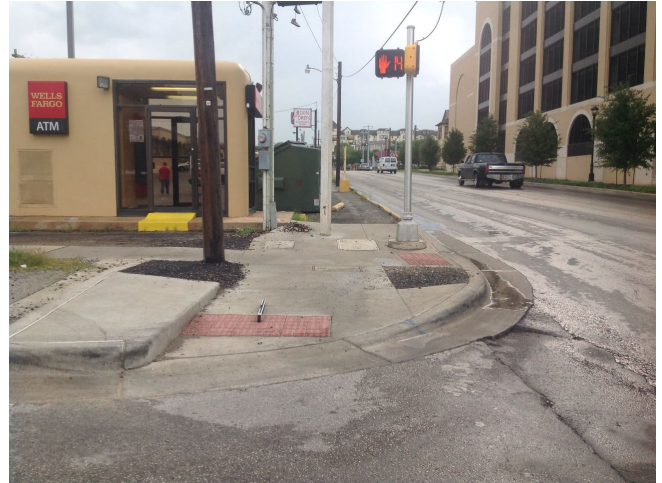
Ramp Elements	Curb ramp provided where an accessible route crosses a barrier:	YES
	Is the slope of the ramp 1:12 or less:	YES
	Transition from curb ramp slope to roadway free from abrupt changes, no greater than 1:20:	NO
	Ramp is at least 36" wide:	YES
	Ramp surface is stable, firm, and slip resistant:	YES
Flare	Flares (if present) are 1:10 or less measured along the curb line; or If landing at top of ramp is not provided flares are 1:12 or less:	NO
Detectable Warning Surface	Curb ramp is located such that it does not project into roadway or parking aisles:	N/A
	Detectable warning is present:	YES
	DWS maintains correct geometric controls; 0.9" diameter domes, 0.2" in height, spaced at 2.35" and visually contrasts adjacent ramp surface:	YES
Special Ramps	Ramp maintains defined edges parallel to direction of pedestrian travel; maintains 4'x4' turning pad contained in crosswalk; flared sides 24" segment on each side of ramp within crosswalk lines:	N/A

Ramp is located so they will not be obstructed by parked vehicles:	N/A
	Ramp wholly contained within the crosswalk lines:	YES
	If island is present; Island maintains a cut through at street level or ramps on either side with landing between them:	N/A
